Home Inspection Report

Prepared for: Martin King
Date: 4/6/2010

Property address: 300 Magnolia St.
Charleston SC 29402

Inspected by: Stephen Houmard
South Carolina License #2046
Solid Ground Home Inspections, LLC
Professional Member:
-American Society of Home Inspectors
(ASHI)

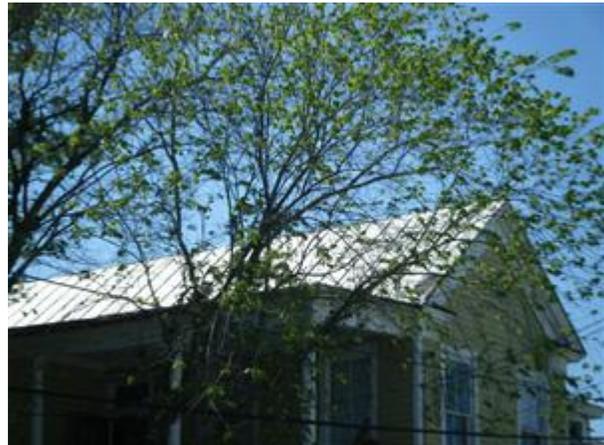
(1) Observed that this home has a metal roof which is older, however the exact age could not be determined. For your reference, the average metal roof can last up to 50 to 70 years and possibly longer depending on maintenance.

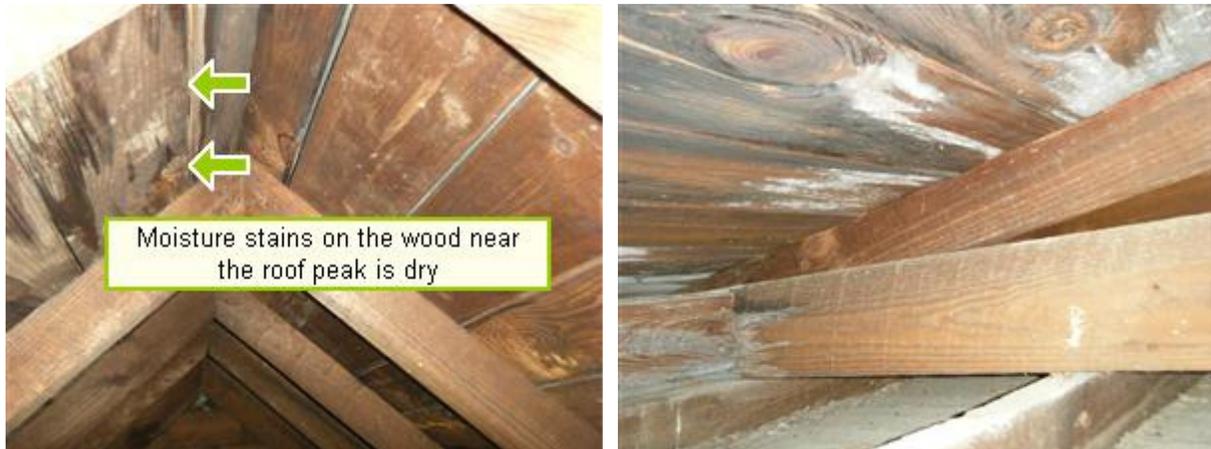
(2) As viewed from inside the attic, observed that there are old moisture stains on the wood sheathing near the roof's peak. When tested, this area is dry. This is just an fyi.

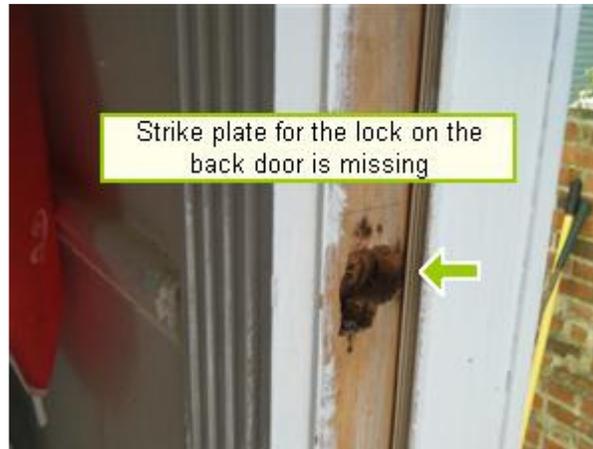
(1) Observed that the strike plate for the lock on the back door is missing. Recommend having a handyman replace the lock, for safety.

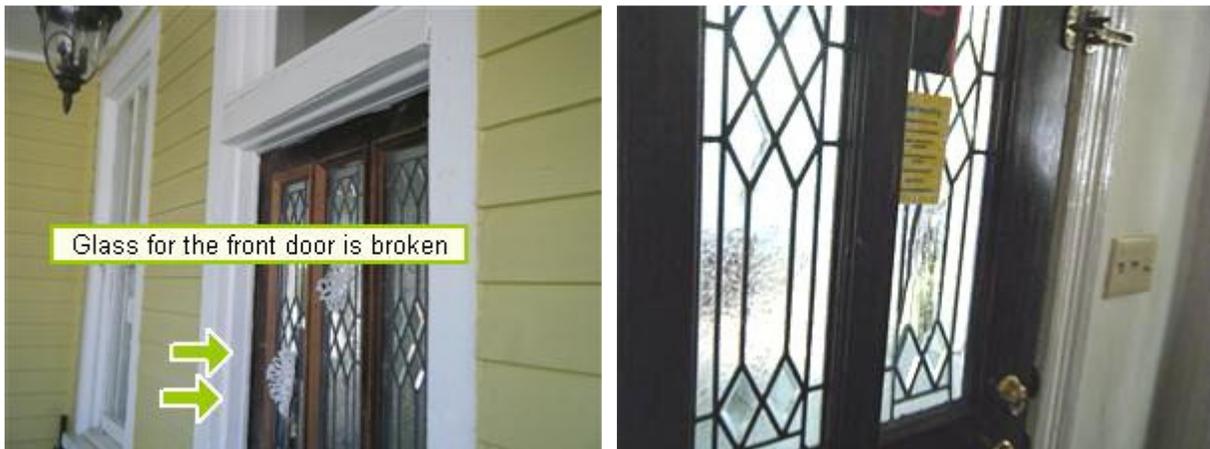
(2) Observed that the window for the front door is broken. Recommend having a contractor replace the glass so that it is again in good condition.

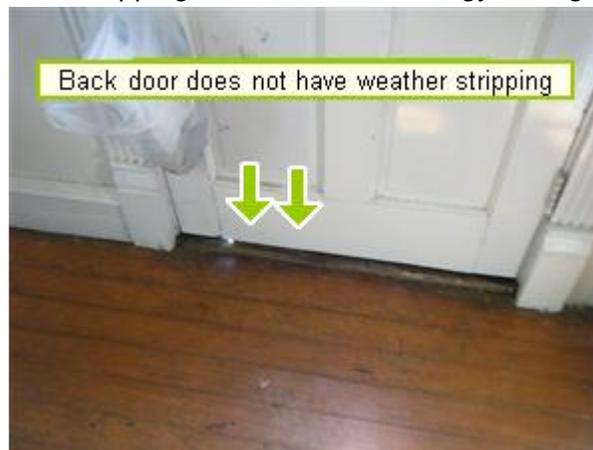
(3) Observed that the back door does not have weather stripping. Recommend having a handyman install weather stripping for this door for energy savings.

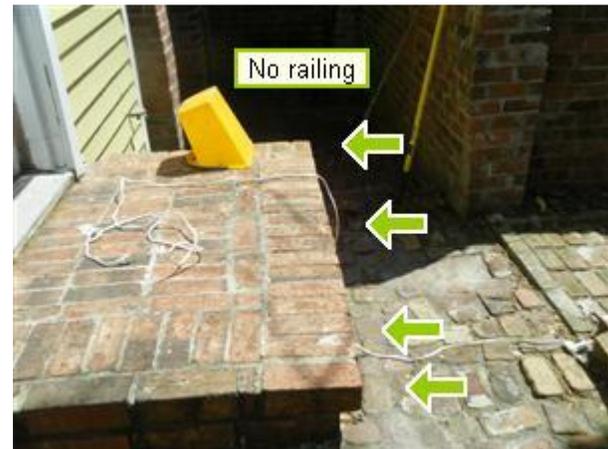
(2) Observed that the back porch and the side porches do not have railings. Recommend having a contractor or handyman install railings with spindles that are no more than 4" apart, for safety.

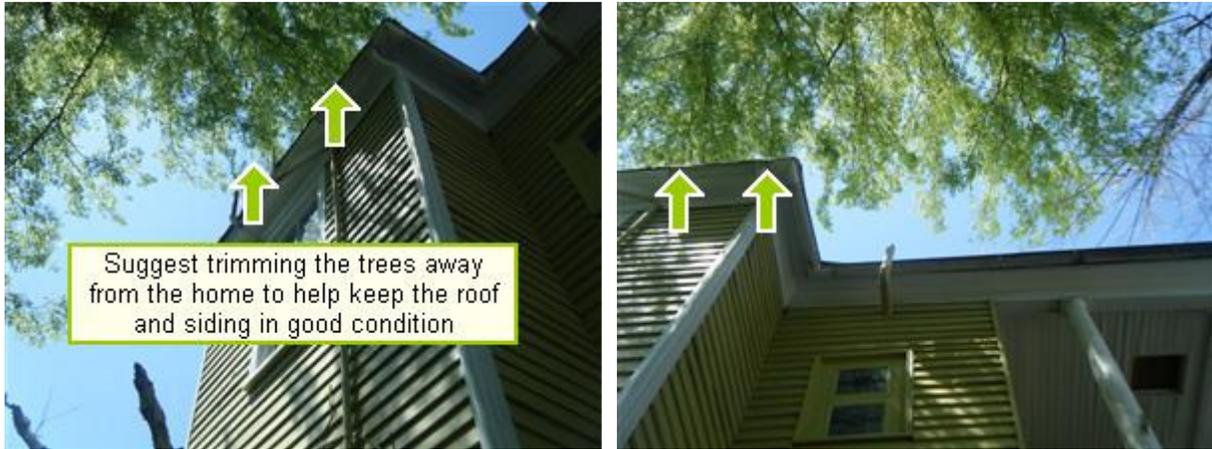
Observed that the trees are in contact with the home. For your reference, tree branches in contact with the home can cause damage during a storm with high winds. Plus, debris on the roof can accelerate deterioration of the shingles. Recommend having a tree company or landscaper trim the tree branches away from the home, where needed.

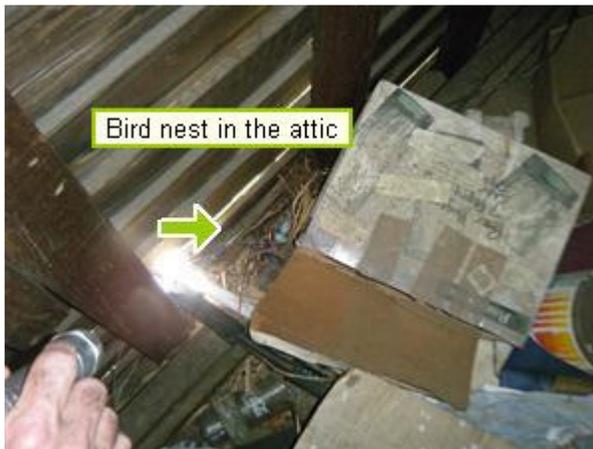
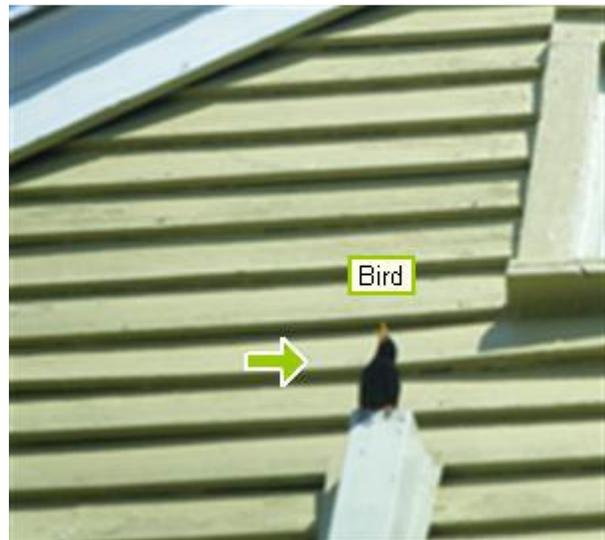
(2) Observed that there is a bird nest in the rear of the attic. Recommend having a handyman seal the openings to the attic to help keep pests out.

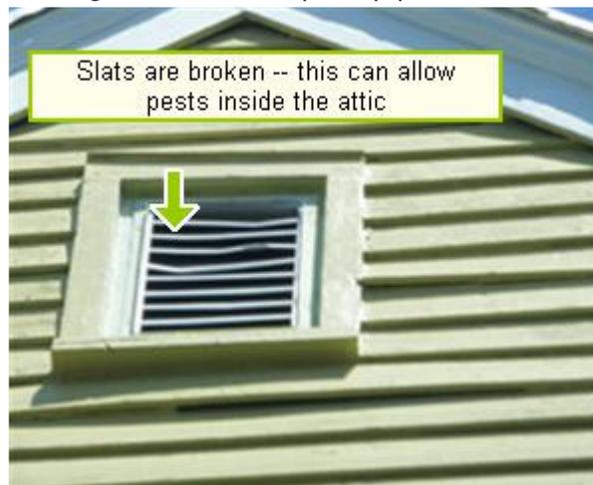
(2) Please note that one or more of the slats for the gable vent are broken -- this can allow pests to enter the attic. Recommend having a contractor or handyman repair the slats and install a screen behind the gable vent to help keep pests out.

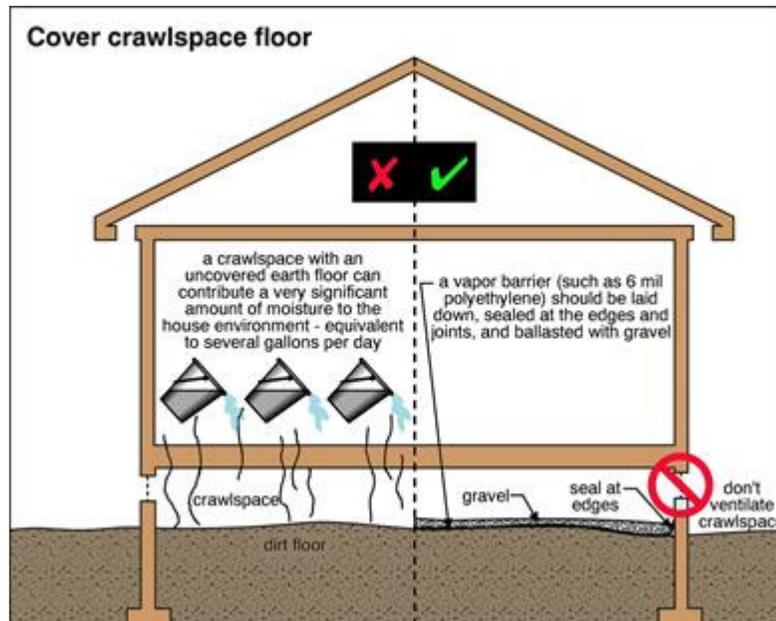
Observed that the ground in the crawlspace is not covered with a vapor barrier (plastic). For your reference, a vapor barrier helps to reduce moisture and dampness in the crawlspace which can cause the house to smell musty. Additionally, excess moisture encourages the growth of mold and mildew, the decay fungi which leads to wood rot and

which can damage the wood and masonry components which comprise the foundation. Therefore, the goal is to keep the crawlspace as dry as possible. Recommend installing a 6 mil plastic sheet on the entire ground in the crawlspace, making sure to overlap seams and have it extend up each wall by 6 inches.

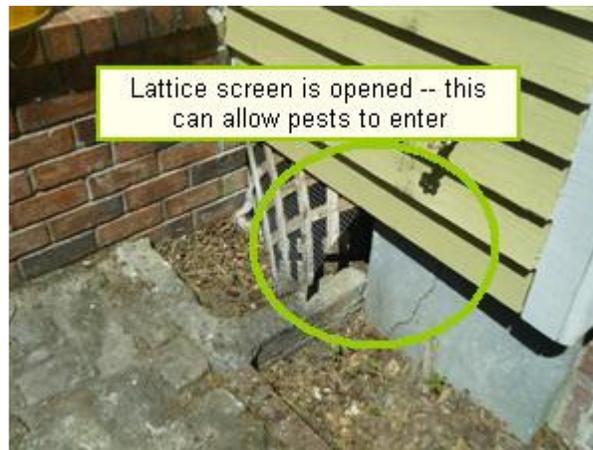
(2) Observed that some of the lattice screen which encloses the crawlspace has been opened -- this will allow pests to enter. Recommend having a handyman replace the sections of lattice screen which are damaged and install a screen behind them to help keep pests out.

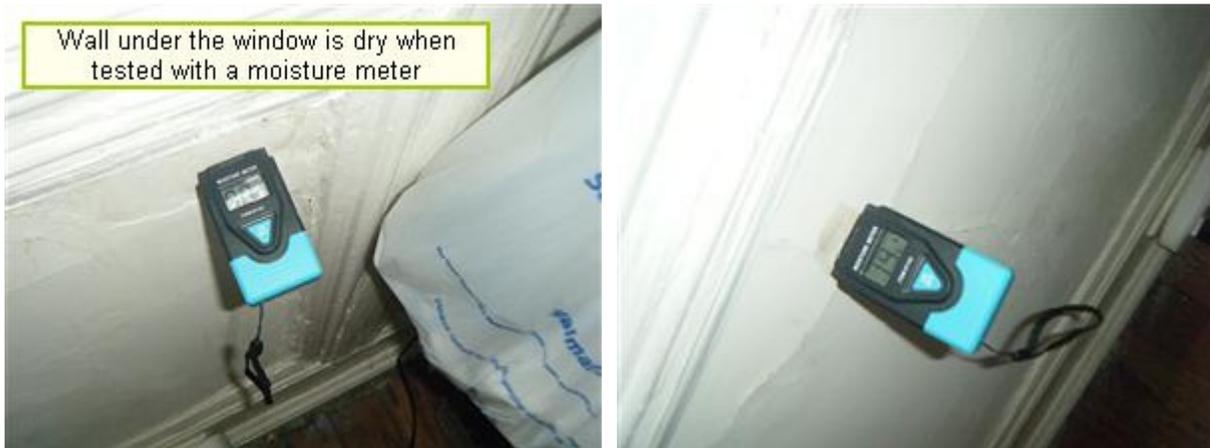
(1) Observed that the wall under the windows in the downstairs front bedroom have moisture stains and damage. The wall is dry when tested with a moisture meter. Please note the moisture could have come in from an open window. Recommend having a contractor or handyman repair the wall, as needed, so it is again in good condition.

stains and damage. The wall is dry when tested with a moisture meter. Please note the moisture could have come in from an open window. Recommend having a contractor or handyman repair the wall, as needed, so it is again in good condition.

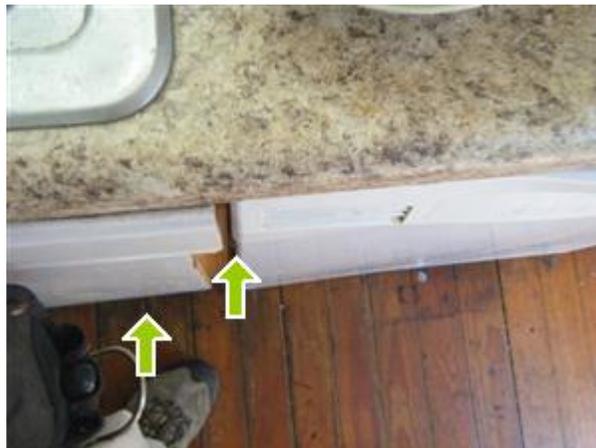
Observed that the cabinets in the kitchen are damaged or are missing drawer fronts. Recommend replacement.

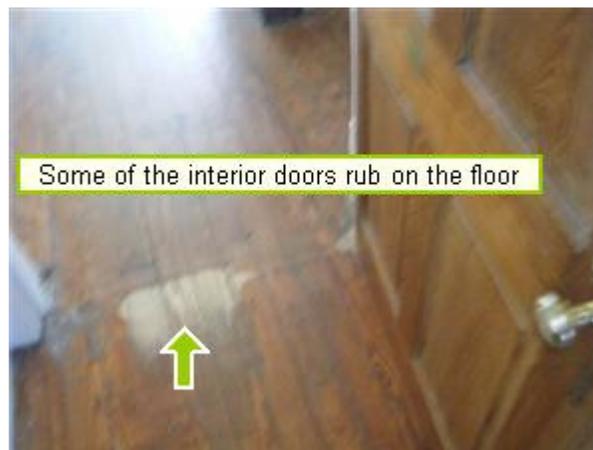
Observed that the interior doors rub on the floor, close on their own and are in poor condition. Recommend having a contractor properly hang the doors so they open and close as they should.

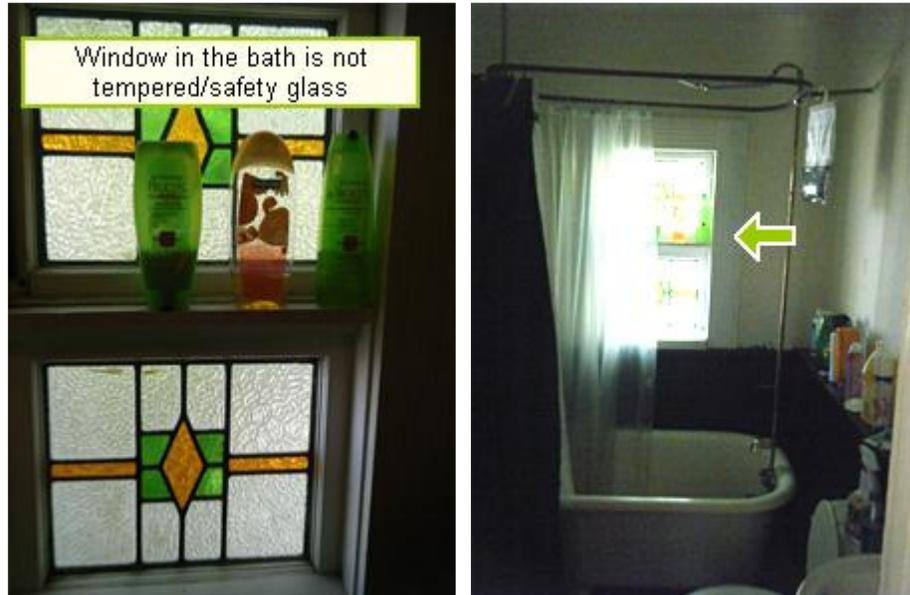
Observed that the window in the bathroom is not safety/tempered glass. For your reference, tempered glass is a strong, break-resistant type of safety glass that, if broken, shatters into small granular pieces or pebbles instead of shards. In a home, windows and glass in certain locations are tempered to help prevent or lessen injuries in the event the glass is broken -- shower and tub window/glass enclosures, doors with glass, window panels in the door or near the door, sliding glass doors, storm doors, very large windows that someone could accidentally walk into and so on. Recommend having a window contractor replace the windows in the bathrooms, where needed, so they are tempered glass, for safety.

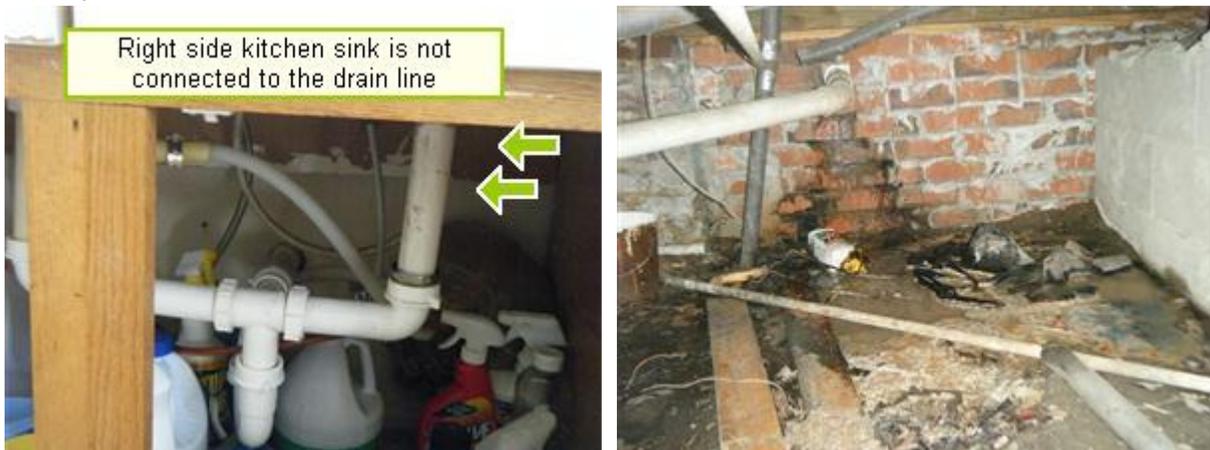
- (3) As viewed from inside the crawlspace, observed that there is standing water on the ground under the kitchen sink from the active leak. Please note this water is giving off a foul smell. Recommend having a contractor clean this area by removing the debris and adding sand.

Observed that the right side kitchen sink is not connected to the drain line and there is an active leak. Please note this leaks down into the crawlspace where there is standing water (as discussed in section 3.0). Recommend having a plumber make the repairs needed to stop the leak.

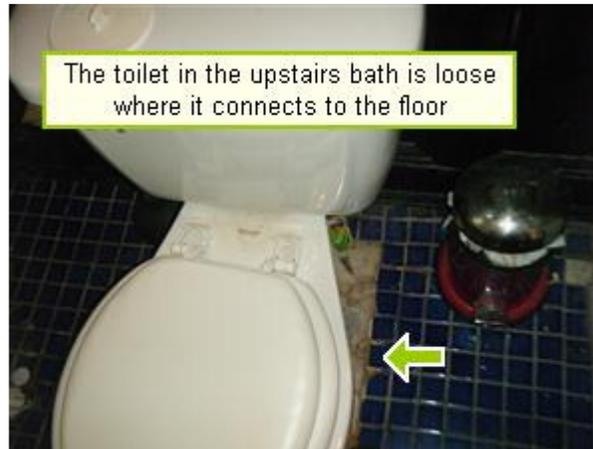
(2) Observed that the toilet in the upstairs bathroom is loose where it connects to the floor -- this is very common. For your reference, a loose toilet bowl may result in a leak at the wax ring and/or at the supply piping connection which can damage the floor and sub-floor below. Recommend having a handyman tighten the floor bolts so the toilet is properly secure.

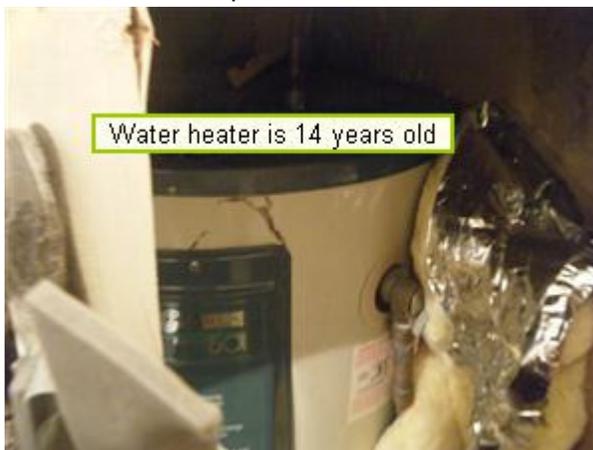
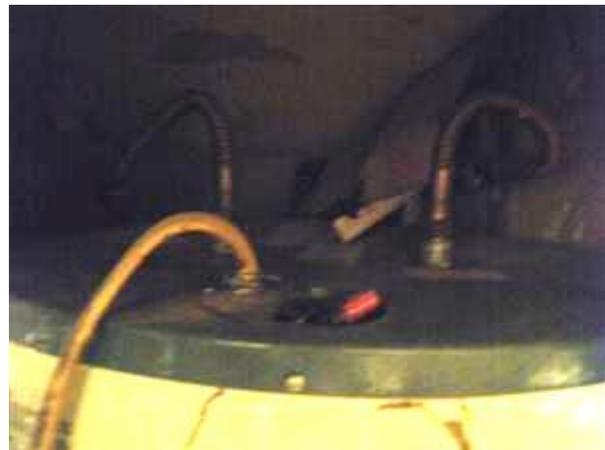
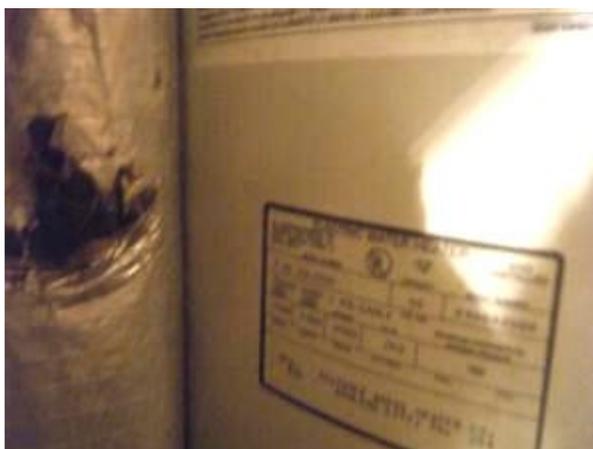
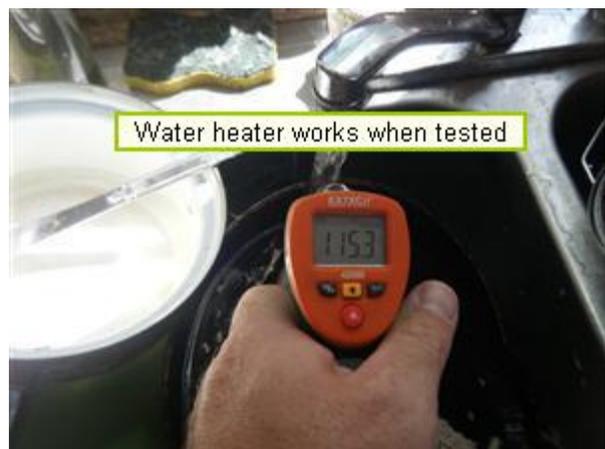
Observed that the electric hot water heater is 14 years old, but works when tested. For your reference, the average hot water heater lasts about 12 years and sometimes longer. Due to age, recommend monitoring the hot water heater for possible problems or leaks and plan to replace this unit in the next few years or so, when needed. This is marked as a 'maintenance and safety' because the heater works fine at this time. However, it will cost between \$500 and \$900 to replace the heater when the time comes.

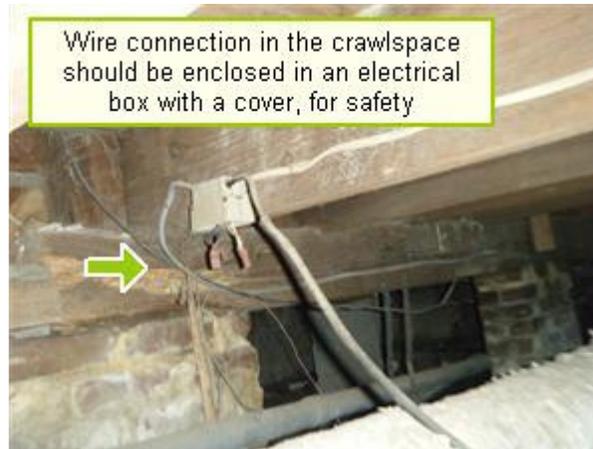
(1) Observed that there is a wire connection in the crawlspace which is not enclosed in an electrical box. Recommend having an electrician enclose this connection in an electrical/junction box with a cover for safety.

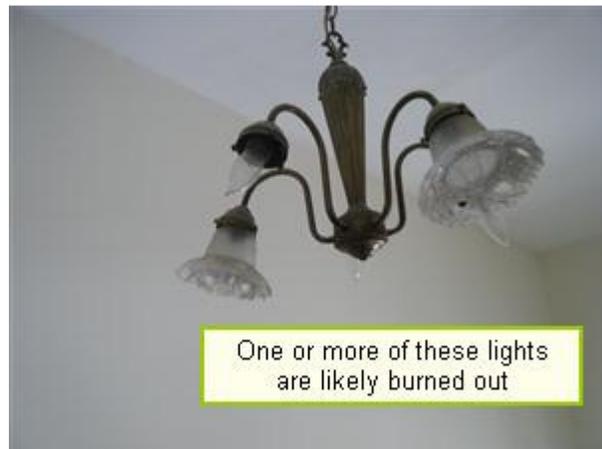
(2) Observed that the light bulbs in the fixture for the kitchen and in one of the hanging chandeliers are likely burned out. Recommend changing the light bulbs.

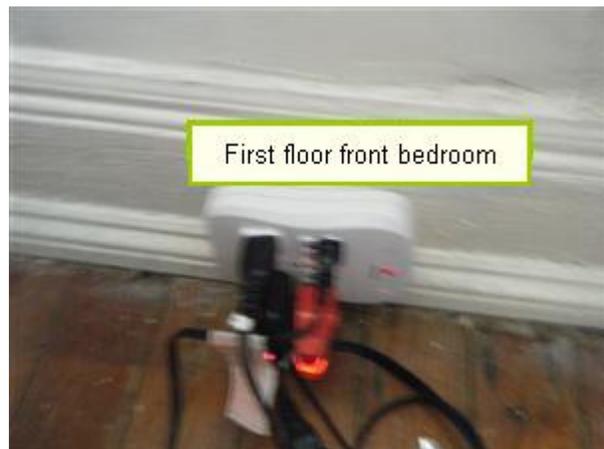
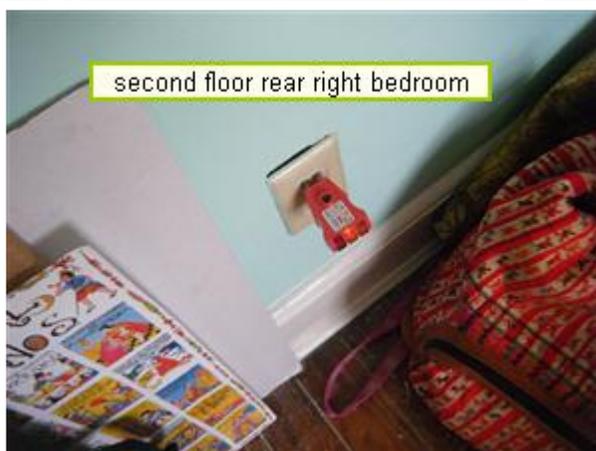
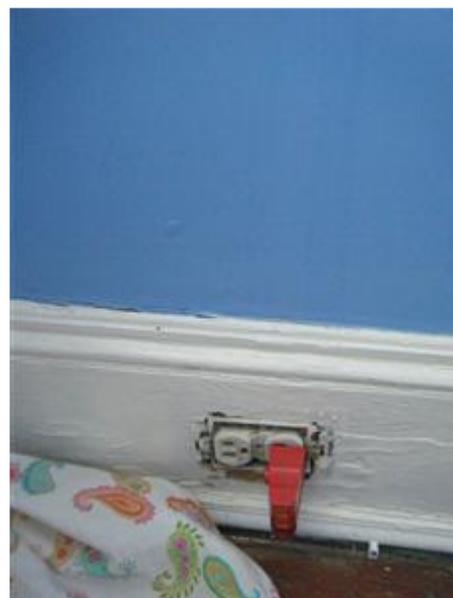
(1) Observed that there are several electrical outlets in the home which aren't grounded -- living room, downstairs front bedroom and upstairs rear right bedroom among others. Recommend having an electrician make the repairs, where needed, so these outlets are properly grounded, for safety.

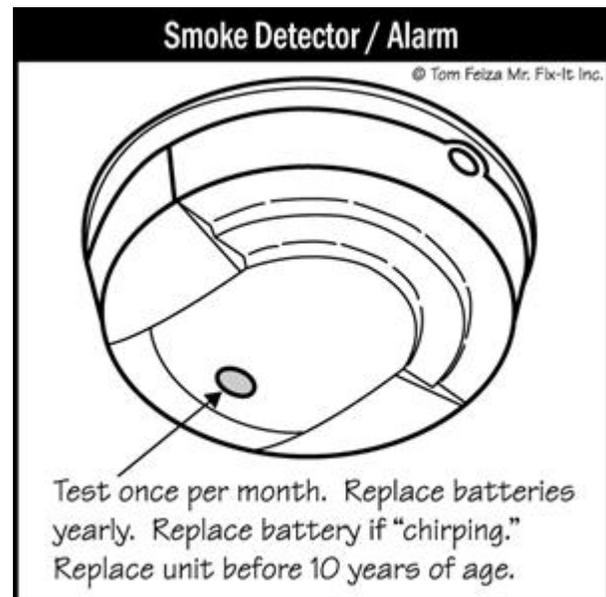
Observed that there are no smoke detectors in this home. Recommend installing one smoke detector in each sleeping area/bedroom, another smoke detector in the hallway outside the sleeping area and at least one smoke detector on each level of the home, for safety. Please note smoke detectors should be positioned ideally on the ceiling or at least 4 inches from ceiling/wall junction. Also, test the detector every 30 days by pushing the test button. Smoke detectors should be replaced every 10 years.

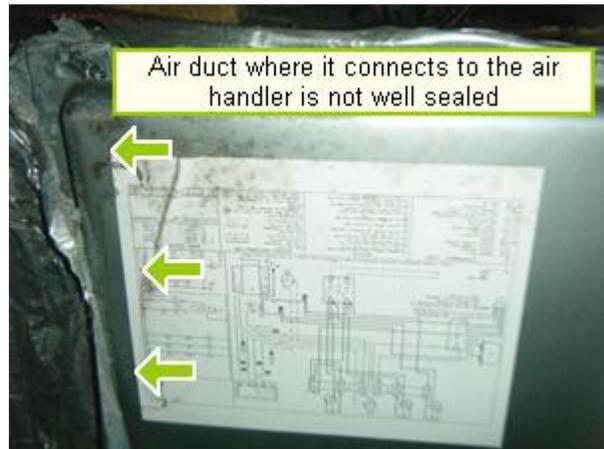
(3) As viewed from inside the attic, observed that the air duct where it connects with the air handler is not well sealed. Recommend having an HVAC repairman clean the air handler, properly connect the duct work and seal it with mastic to ensure a good seal.

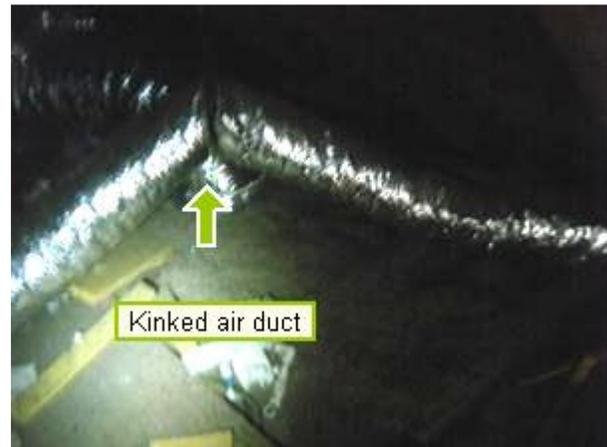
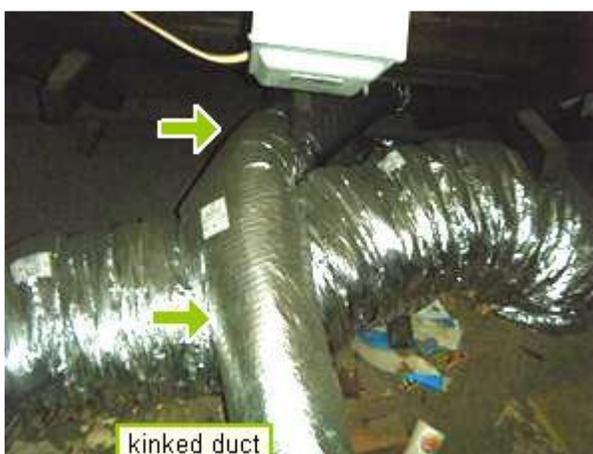
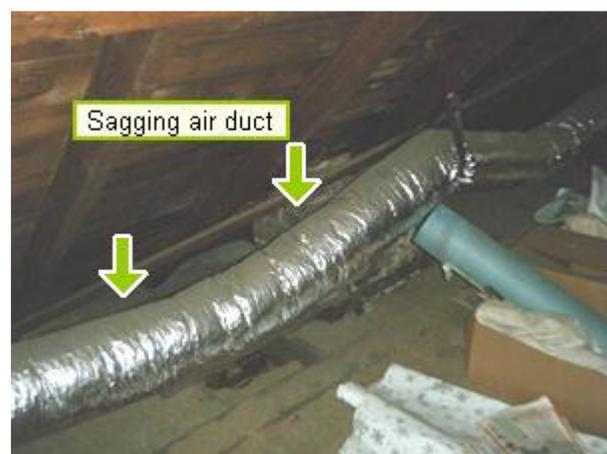
(2) As viewed from inside the attic, observed that one or more of the air ducts are sagging. For your reference, air ducts that aren't well supported can leak, condensation can form and drip onto the ground and/or air flow may be reduced which means that areas in the house may not be as comfortable as they could be. Recommend having a contractor or HVAC repairman add support for the ducts so they hang as straight as possible to facilitate good air flow.

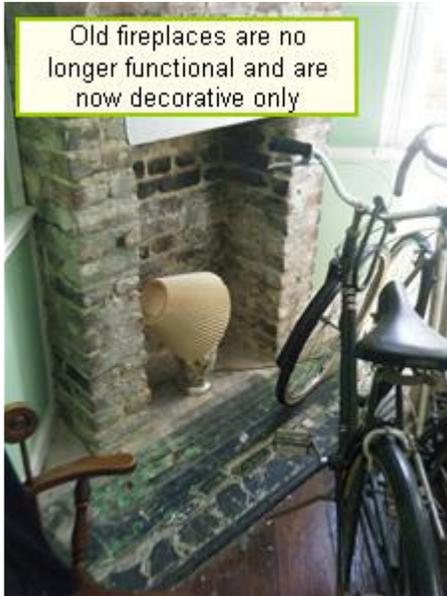
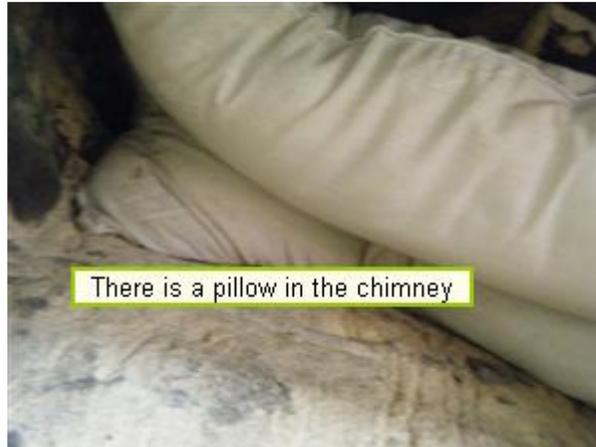
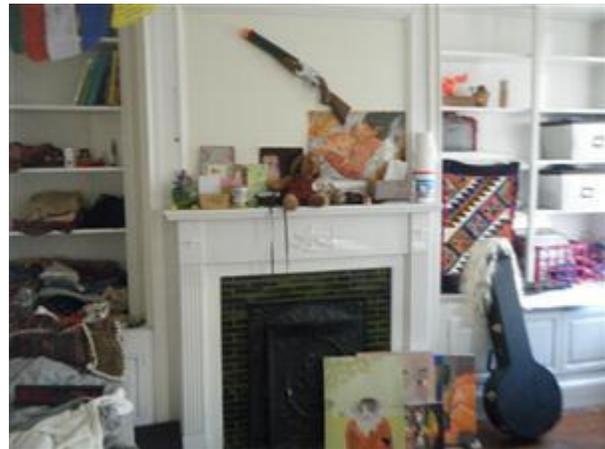
Observed that the fireplaces in the home have pillows in the chimneys to block the cold air. These old fireplaces are no longer functional -- DO NOT USE THEM FOR HEAT.
