Home Inspection Report

Prepared for: Martin King
Date: 4/6/2010

Property address: 300 Magnolia St.
Charleston SC 29402

Inspected by: Stephen Houmard
South Carolina License #2046
Solid Ground Home Inspections, LLC
Professional Member:
-American Society of Home Inspectors
(ASHI)

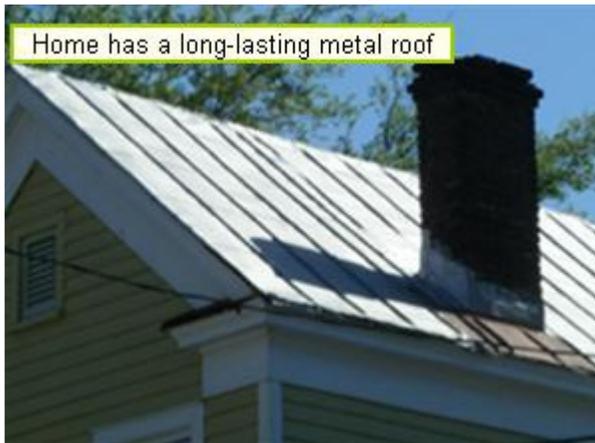
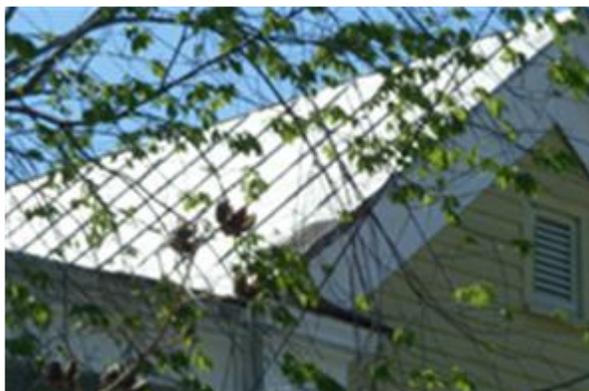
(1) Observed that this home has a metal roof which is older, however the exact age could not be determined. For your reference, the average metal roof can last up to 50 to 70 years and possibly longer depending on maintenance.

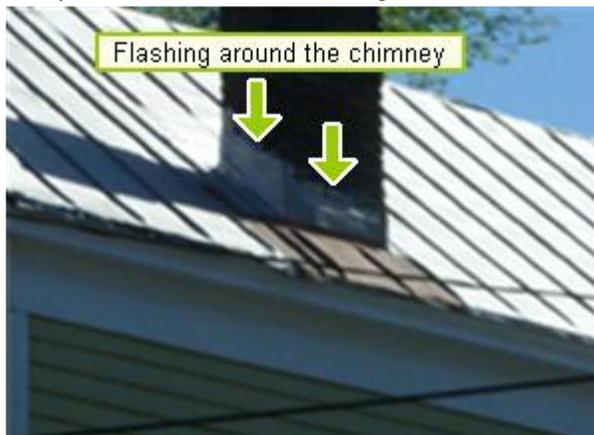
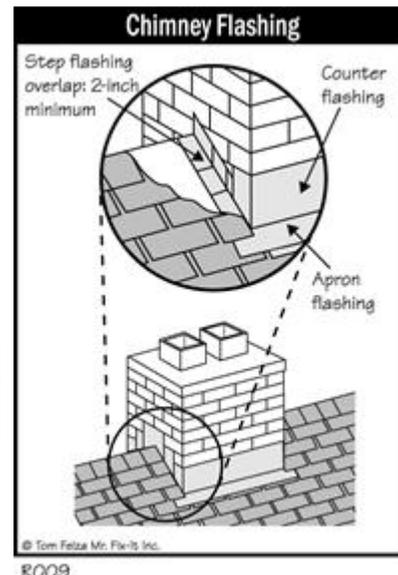
Observed that the flashings are in good condition. For your reference, flashing is a sheet of metal or Neoprene which is installed around pipes and chimneys traveling through the roof to ensure these areas are water tight. Also, flashing is applied along the sidewalls where different parts of the roof come together as well.

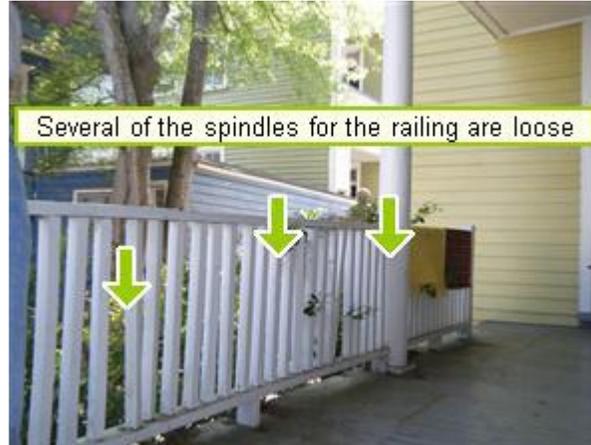
- (1) Observed that the porch railing has several loose spindles. Recommend having a handyman repair the spindles so they are again in good condition, for safety.

(1) Observed that the porch railing has several loose spindles. Recommend having a handyman repair the spindles so they are again in good condition, for safety.

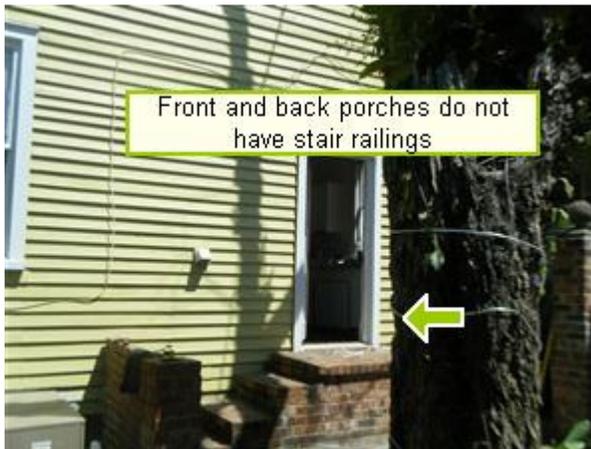
(2) Observed that the back porch and the side porches do not have railings. Recommend having a contractor or handyman install railings with spindles that are no more than 4" apart, for safety.

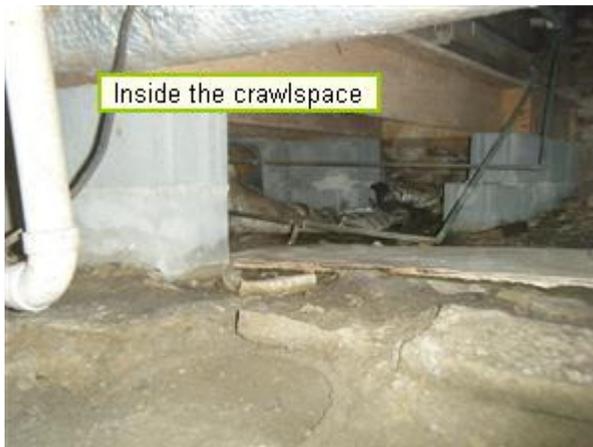
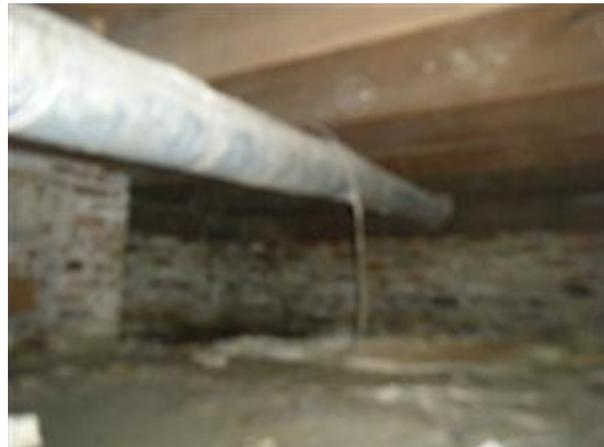
(1) Observed that this home's foundation is a system of brick piers and has a brick skirting (wall) which encloses the crawlspace. For your reference, the goal is to keep the crawlspace as dry as possible to protect/preserve the structural integrity of the wood and masonry which comprise the foundation. For your reference, wood which has a moisture content of 20% or more (from direct contact with moisture or from a very humid environment) conditions are ripe for the growth of mold/mildew, the decay fungi which leads to wood rot and termites. When rot sets, the wood loses its structural integrity and the rot can spread if not corrected. In most cases, installation of gutters to divert rain water away from the foundation, a vapor barrier on the ground to reduce moisture vapor along with good ventilation in the crawlspace are usually enough to keep moisture content below 20%.

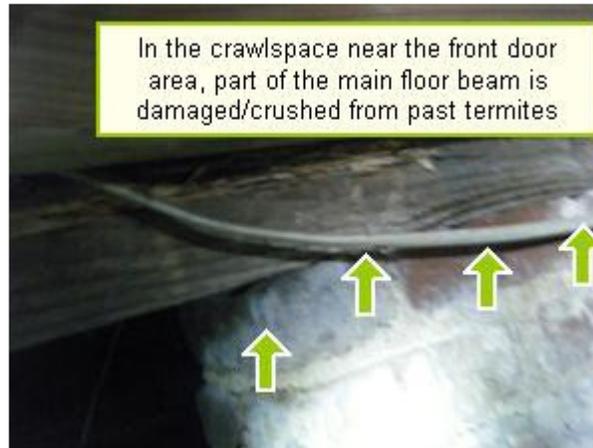
(2) As viewed from inside the crawlspace, observed that part of the main floor beam (which runs from the front of the home to the rear) is damaged in one section located near the front door. Specifically, the beam is crushed in this section from termite damage and the weight of the home. Recommend having a foundation contractor repair or replace this part of the beam, as needed, so it is again strong and sturdy.

(2) As viewed from inside the crawlspace, observed that part of the main floor beam (which runs from the front of the home to the rear) is damaged in one section located near the front

door. Specifically, the beam is crushed in this section from termite damage and the weight of the home. Recommend having a foundation contractor repair or replace this part of the beam, as needed, so it is again strong and sturdy.

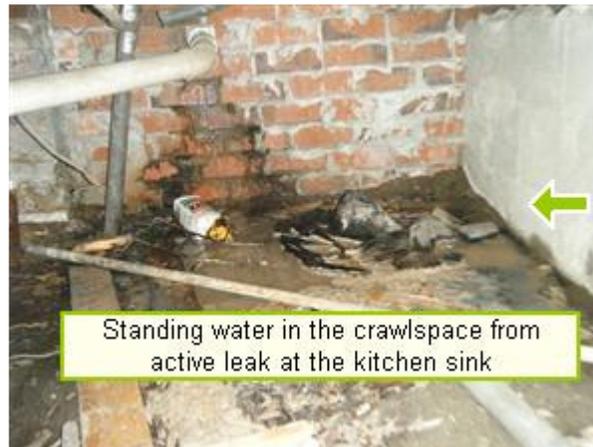
- (3) As viewed from inside the crawlspace, observed that there is standing water on the ground under the kitchen sink from the active leak. Please note this water is giving off a foul smell. Recommend having a contractor clean this area by removing the debris and adding sand.

Observed that the right side kitchen sink is not connected to the drain line and there is an active leak. Please note this leaks down into the crawlspace where there is standing water (as discussed in section 3.0). Recommend having a plumber make the repairs needed to stop the leak.

(3) As viewed from inside the crawlspace, observed that there is standing water on the ground under the kitchen sink from the active leak. Please note this water is giving off a foul smell. Recommend having a contractor clean this area by removing the debris and adding sand.

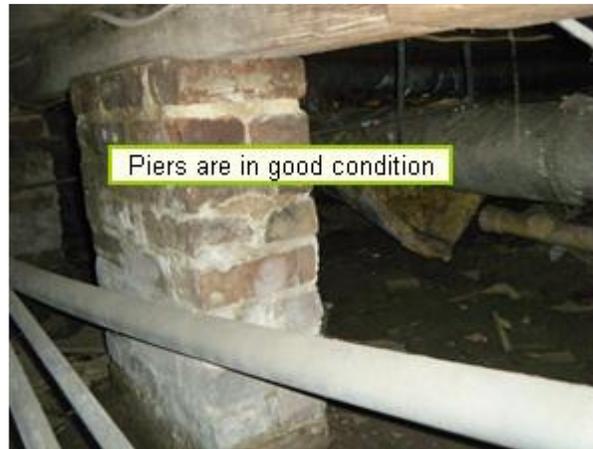
Observed that the piers are in good condition. For your reference, columns/piers are an important structural component of the foundation. Their purpose is to transfer loads from beams down through the footings to the soil.

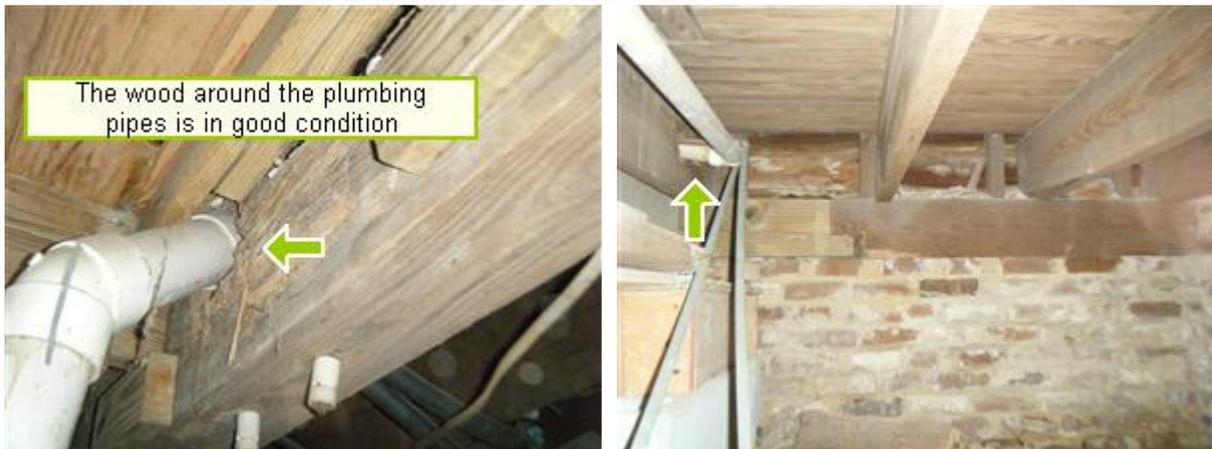
As viewed from inside the crawlspace, the wood (sub-floor and floor joists) around the plumbing pipes is in good condition. *Please note I could not see the sub-floor under the first floor bathroom toilet due to debris and obstructions.*

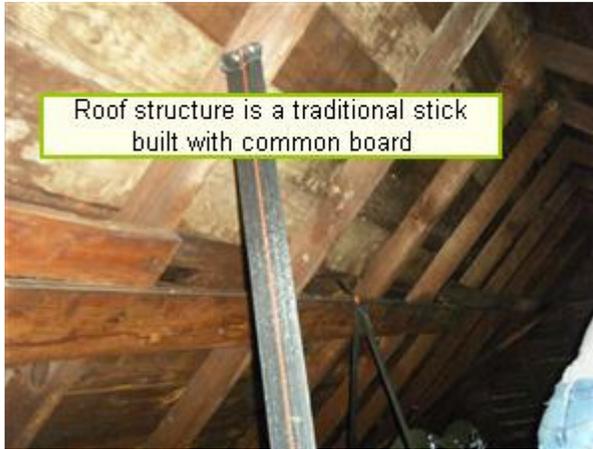
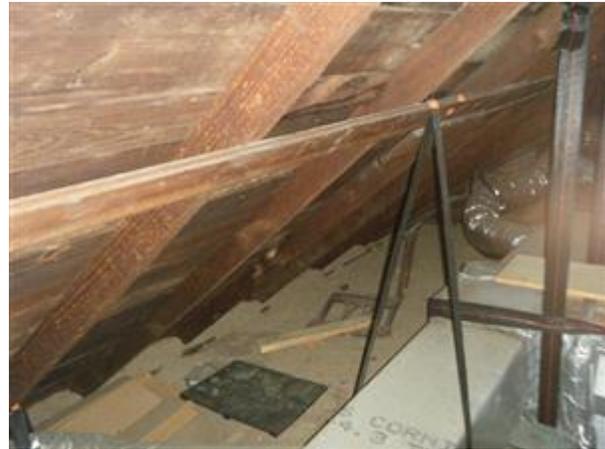
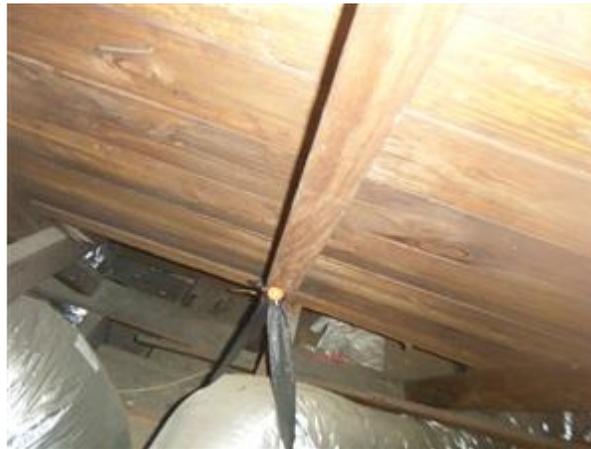
(1) Observed that the roof has a traditional stick built structure with a common board.

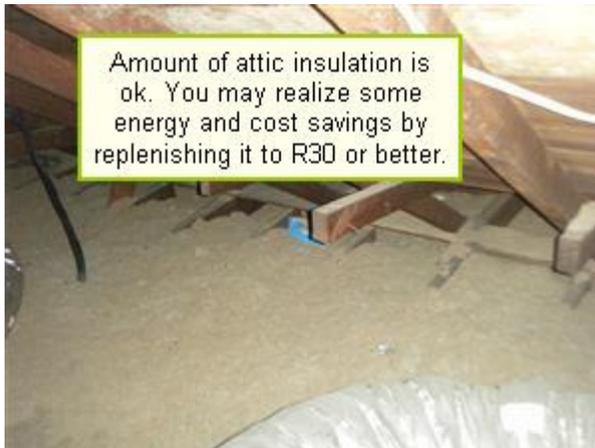
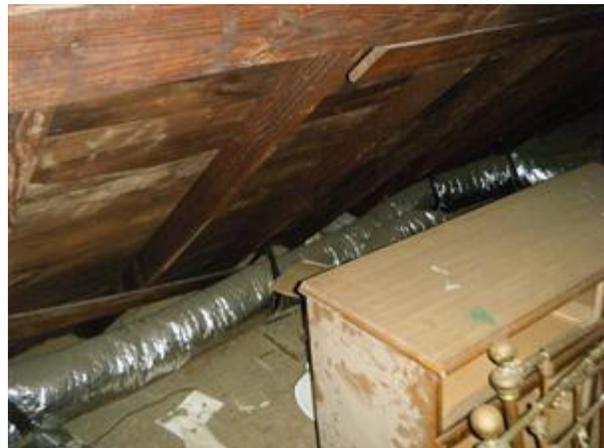
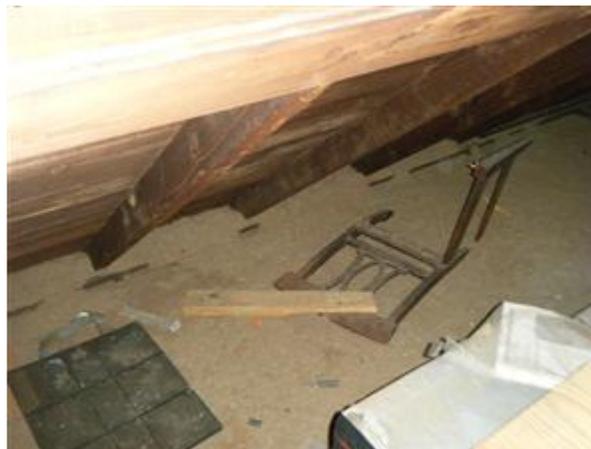
Observed that this home has an amount of insulation on the attic floor which equates to R-19 -- very common for a home of this age. To maximize energy efficiency of the home, recommend having a contractor install additional insulation to reach R-30 or better. For your reference, the effectiveness of insulation is measured by its R-number which is its ability to resist the flow of heat. The higher the R-number, the greater the resistance to winter heat loss or summer heat gain. Today's standard for insulation in newer homes is R-30 or better.

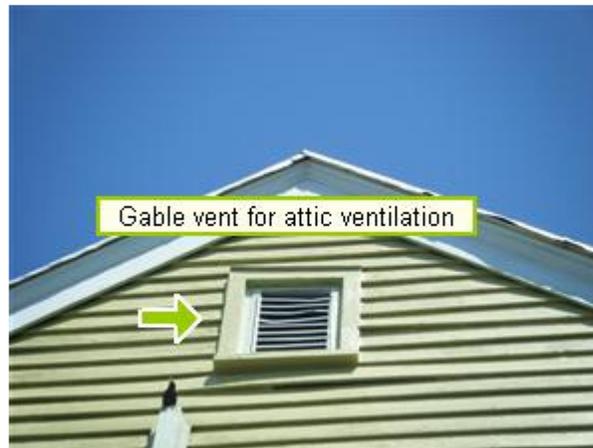
(1) Observed that the attic is ventilated with gable vents -- while this was common when this home was built, this system really does not provide enough ventilation. Recommend having a roofing contractor increase the attic ventilation when you have an opportunity -- this will significantly impact the life expectancy of your insulation, the new shingles and the components inside your attic.

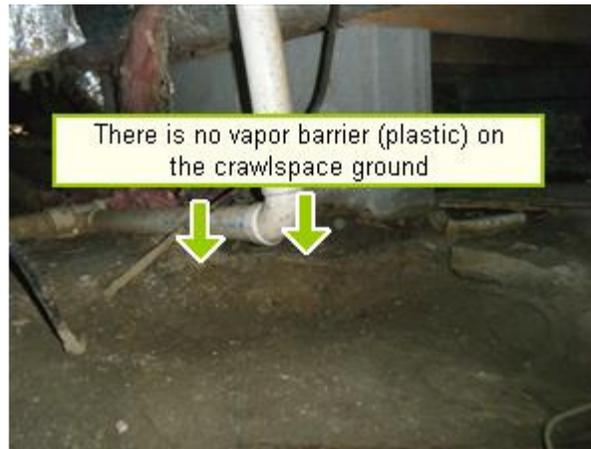
Observed that the ground in the crawlspace is not covered with a vapor barrier (plastic). For your reference, a vapor barrier helps to reduce moisture and dampness in the crawlspace which can cause the house to smell musty. Additionally, excess moisture encourages the growth of mold and mildew, the decay fungi which leads to wood rot and

wood-eating insects which can damage the wood and masonry components which comprise the foundation. Therefore, the goal is to keep the crawlspace as dry as possible. Recommend installing a 6 mil plastic sheet on the entire ground in the crawlspace, making sure to overlap seams and have it extend up each wall by 6 inches.

Observed that the ground in the crawlspace is not covered with a vapor barrier (plastic). For your reference, a vapor barrier helps to reduce moisture and dampness in the crawlspace which can cause the house to smell musty. Additionally, excess moisture encourages the growth of mold and mildew, the decay fungi which leads to wood rot and wood-eating insects

which can damage the wood and masonry components which comprise the foundation. Therefore, the goal is to keep the crawlspace as dry as possible. Recommend installing a 6 mil plastic sheet on the entire ground in the crawlspace, making sure to overlap seams and have it extend up each wall by 6 inches.

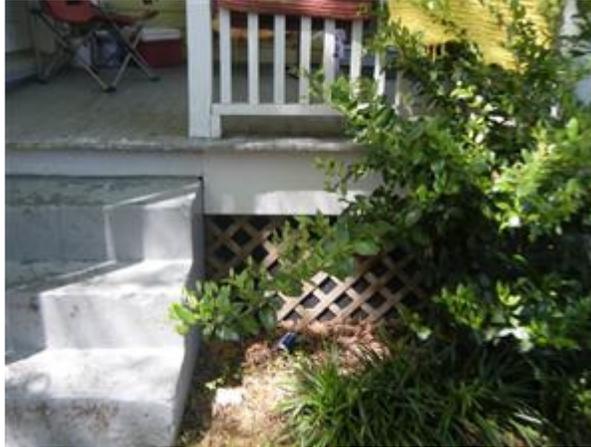
(1) Observed that the crawlspace is well ventilated with lattice screen -- this helps keep the crawlspace as dry as possible to protect the structural integrity of the wood and masonry components which comprise the foundation.

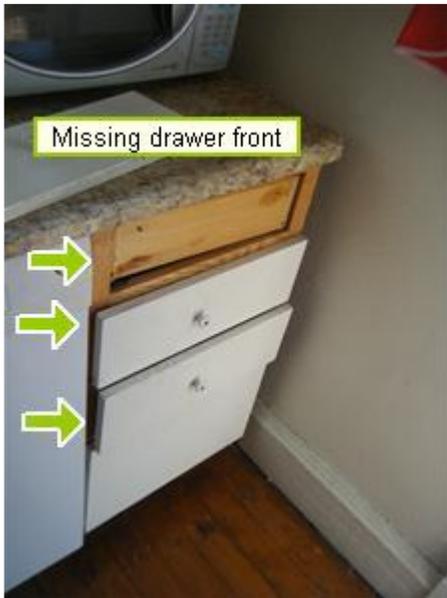
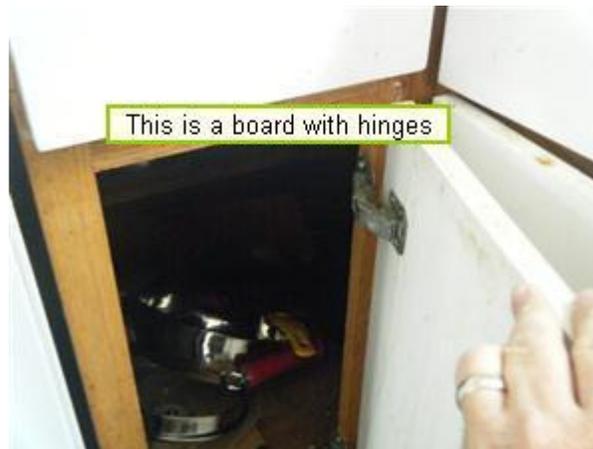
Observed that the cabinets in the kitchen are damaged or are missing drawer fronts. Recommend replacement.

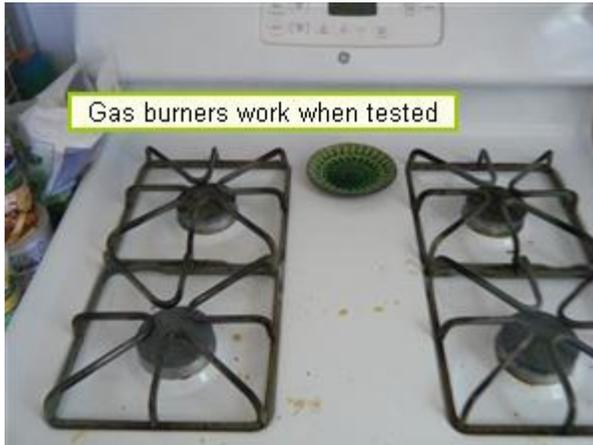
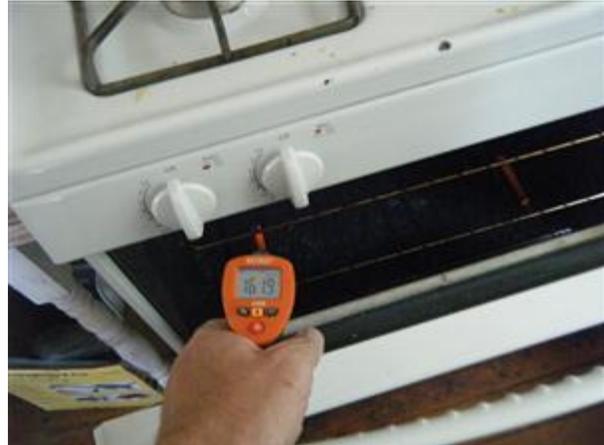
Observed that the oven and cooktop appear to be working well -- they were tested with a infrared red thermometer to ensure they are heating as they should. Please note I did not test for maximum temperature. For your reference, the average electric range will last about 17 years (gas ranges last about 19 years) and the cooktop will last between 13 and 20 years.

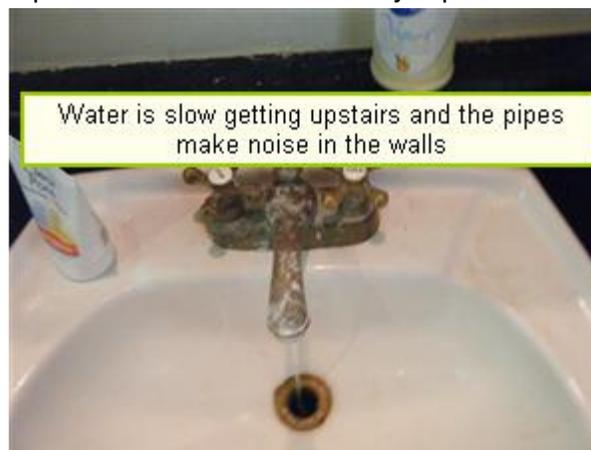
(1) Observed that the water to the second floor is slow and the pipes make noise in the walls. Recommend having a plumber make the necessary repairs to the second floor plumbing.

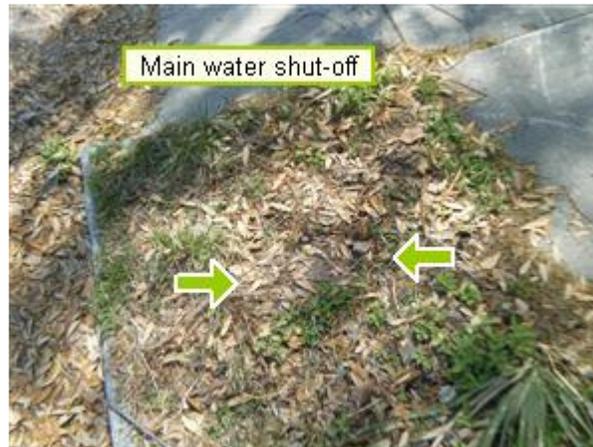
Observed that the main water shut-off is located in the front yard at the meter. If you need to

do any plumbing work in the house, or if one of your pipes breaks, you'll need to know where to shut-off the water so repairs can be made.

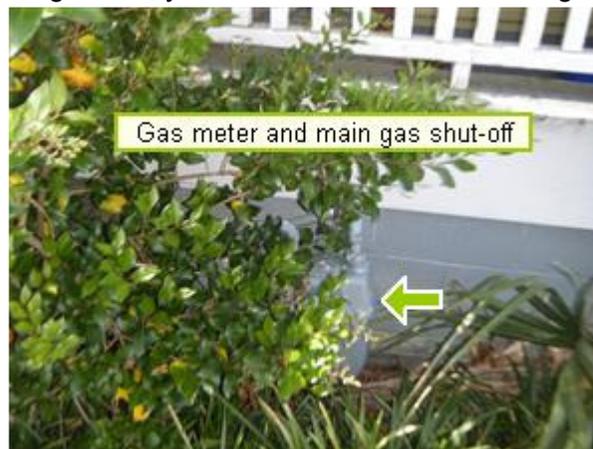
(1) The main fuel/gas shut-off is located at the gas meter outside. In the event that repairs need to be made to the gas line, you'll need to know where the gas shut-off is located.

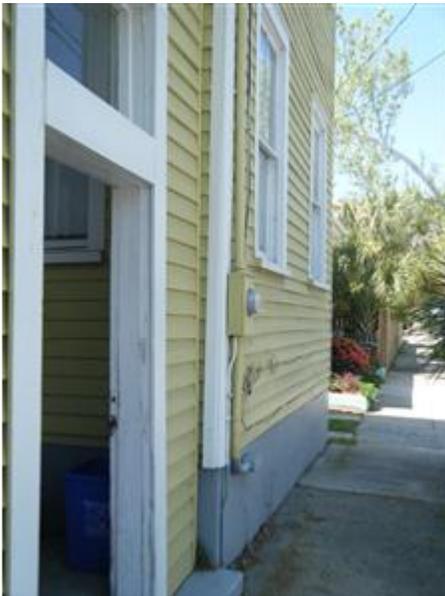
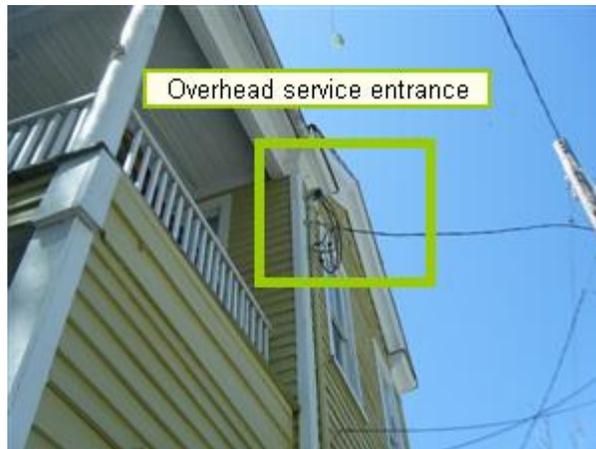
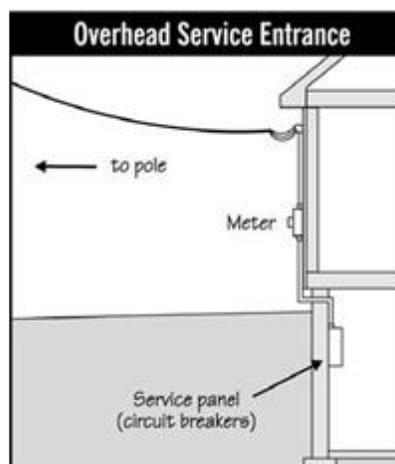
Observed that the overhead service entrance conductor (where the power enters the home from the street), electrical meter and grounding rod are in good working condition.

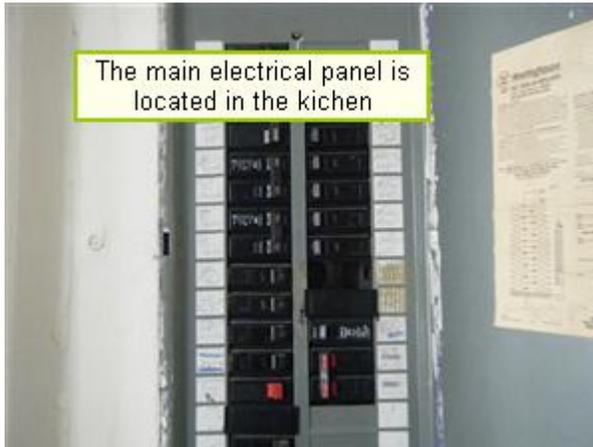
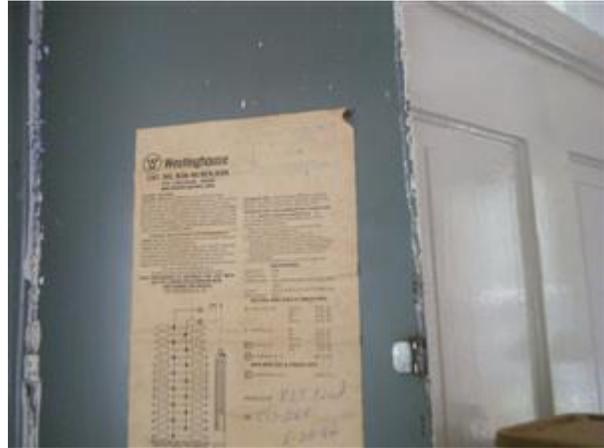
The main electrical panel is located in the kitchen.

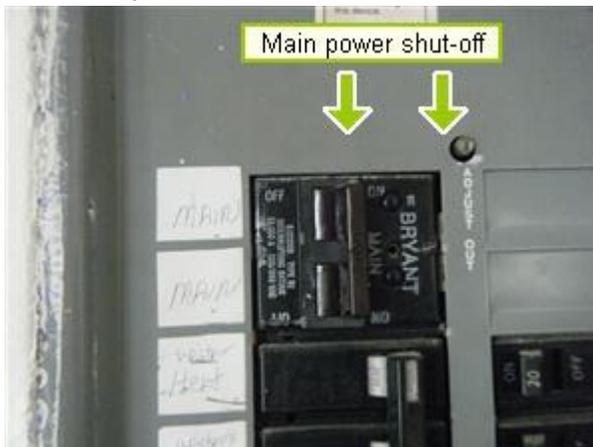
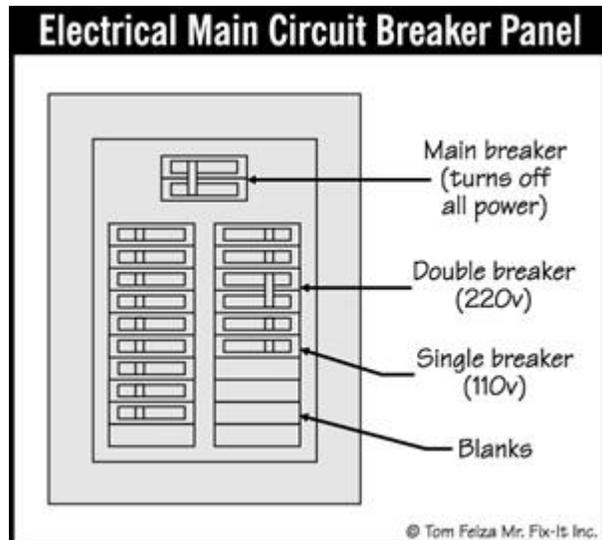
Observed the main electrical disconnect (also called a main breaker) is on located on the main electrical panel. It is helpful to know where the main breaker is in case you need to turn off the power for the whole home.

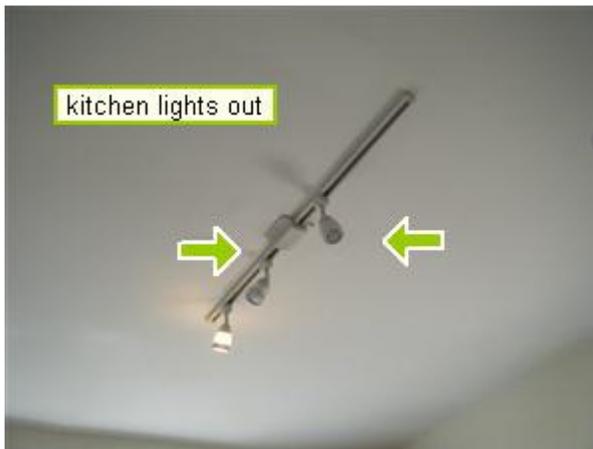
(2) Observed that the light bulbs in the fixture for the kitchen and in one of the hanging chandeliers are likely burned out. Recommend changing the light bulbs.

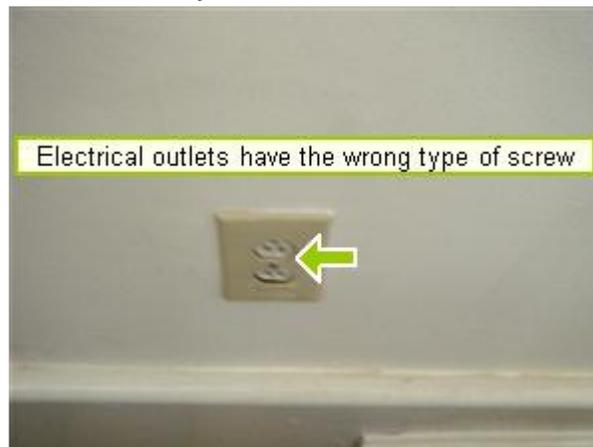
(3) Observed that the electrical outlets through out the home are installed with the wrong type of screw -- a safety hazard. For your reference, screws which are not the right size can penetrate too deep into the outlet causing damage to the wiring and may result in an electrical shock for the homeowner (i.e. when removing the face plate to paint the wall). Recommend having an electrician replace the face plate and/or the outlets, as needed, so they are properly installed, for safety.

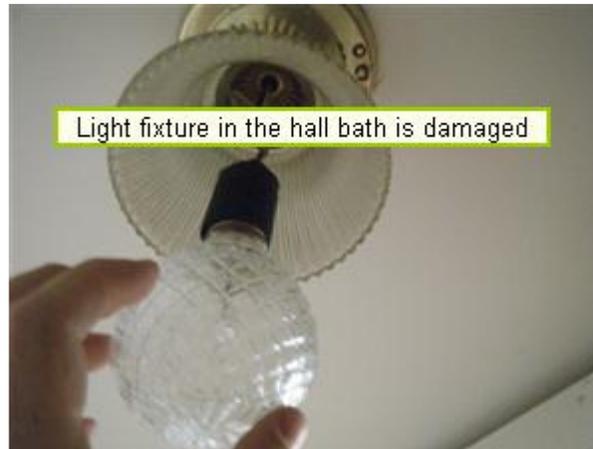
(4) Observed that the light in the hall bathroom is damaged. Recommend having an electrician replace this fixture.

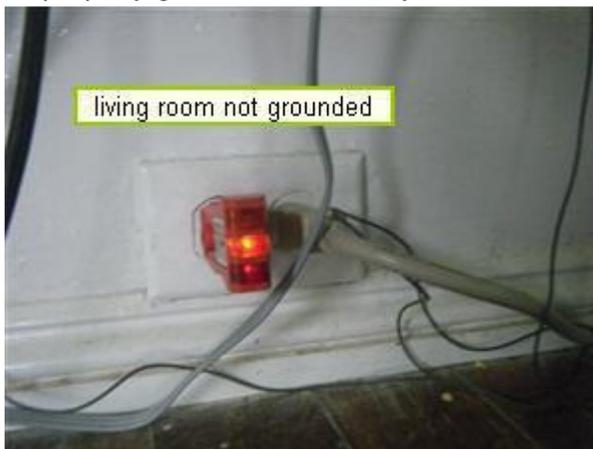
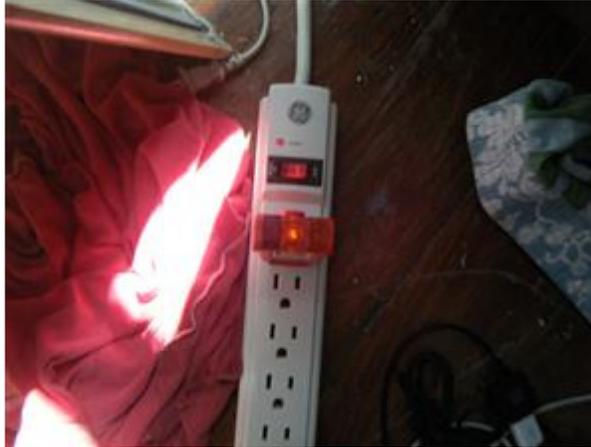
(1) Observed that there are several electrical outlets in the home which aren't grounded -- living room, downstairs front bedroom and upstairs rear right bedroom among others. Recommend having an electrician make the repairs, where needed, so these outlets are properly grounded, for safety.

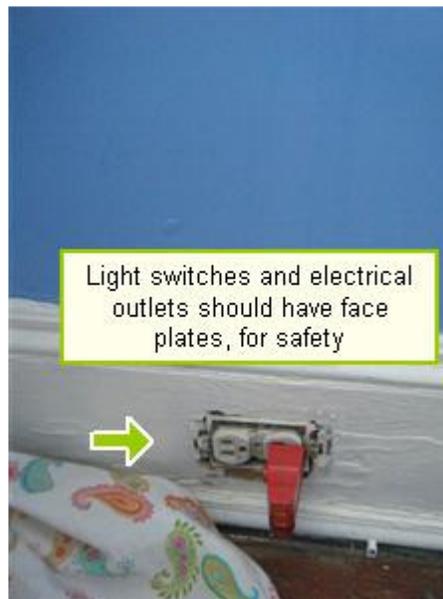
(3) Observed that one or more electrical outlets and light switches do not have covers/face plates. Recommend having a handyman or the homeowner install covers/face plates, where needed, for safety.

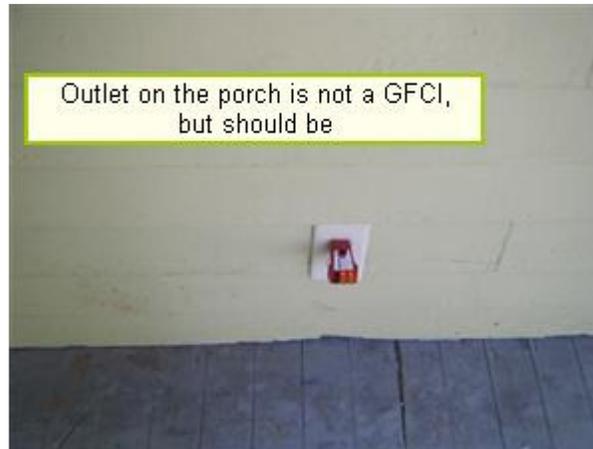
(1) Observed that this home has GFCI (Ground Fault Circuit Interrupters) outlets in the kitchen and the bathroom. Recommend having an electrician install GFCI outlets elsewhere in the home -- inside and outside within 6 feet of water for safety, such as on the porch, for safety.

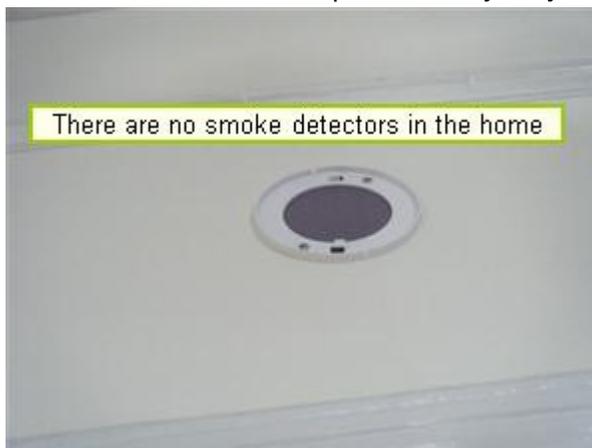
MO11

Observed that there are no smoke detectors in this home. Recommend installing one smoke detector in each sleeping area/bedroom, another smoke detector in the hallway outside the sleeping area and at least one smoke detector on each level of the home, for safety. Please note smoke detectors should be positioned ideally on the ceiling or at least 4 inches from ceiling/wall junction. Also, test the detector every 30 days by pushing the test button. Smoke detectors should be replaced every 10 years.

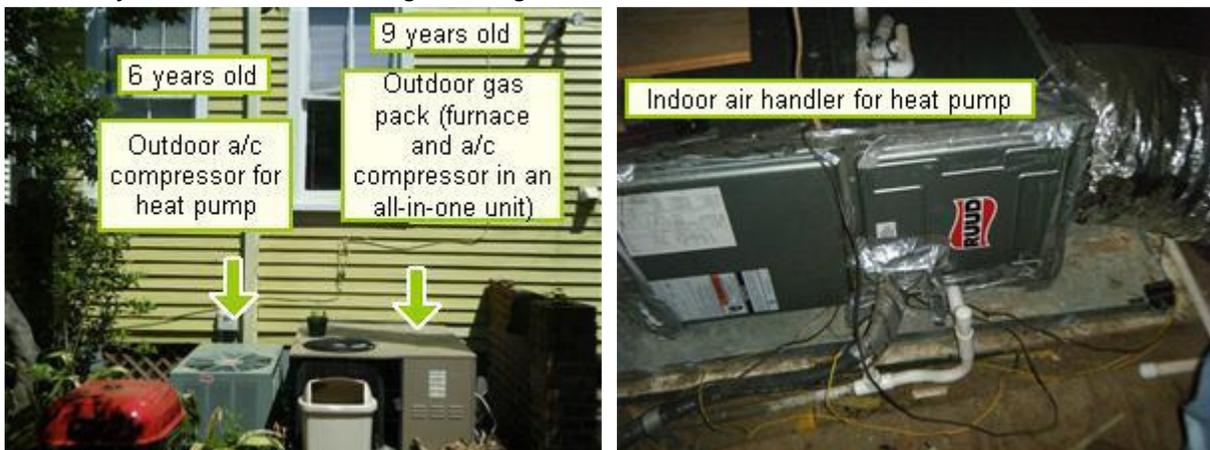
(1) Observed that there is an outdoor gas pack (a furnace and a/c compressor in an all-in-one unit) to heat and cool the downstairs. Also, there is a heat pump system consisting of an outdoor compressor and an indoor air handler which work together to heat and cool the upstairs. The heat pump is 6 years old and the gas pack is 9 years old. For your reference, outdoor a/c compressors and gas furnaces generally last up to 15 years and air handlers up to 20 years and all often longer with good maintenance.

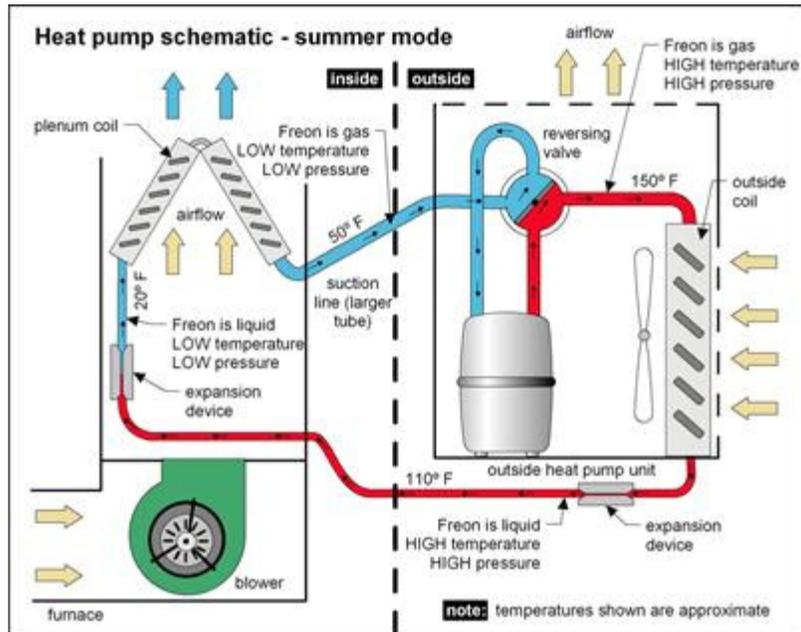
(2)
For your reference, heat pumps are used for heating and cooling of your home by

transferring heat between two reservoirs. In the warmer months, the heat pump acts like an air conditioner, moving heat from inside your home to the outside. During winter months, heat from outdoors is transferred to the interior of your home. Amazingly, even a 32° Fahrenheit day still produces enough heat to warm a home via a heat pump.

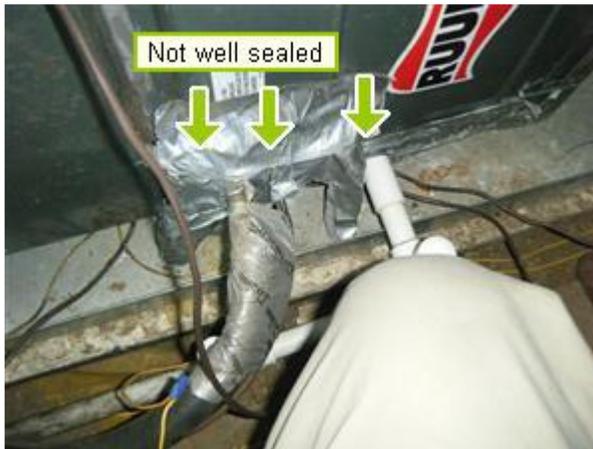
(3) As viewed from inside the attic, observed that the air duct where it connects with the air handler is not well sealed. Recommend having an HVAC repairman clean the air handler, properly connect the duct work and seal it with mastic to ensure a good seal.

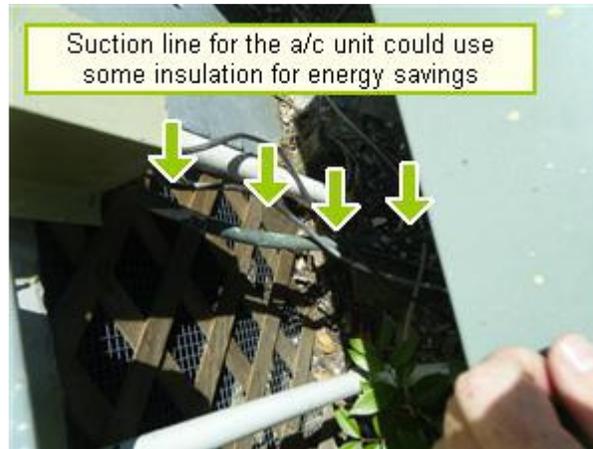
(4) At the outside compressor unit for the HVAC, the suction line is not completely insulated with a foam sleeve -- on this unit, part of the foam sleeve is missing which can cause hinder the home's cooling ability and produce condensation. Recommend having an HVAC repairman insulate the suction line where needed.

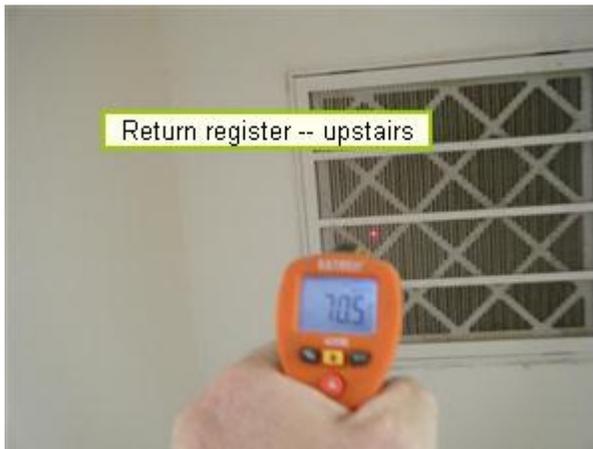
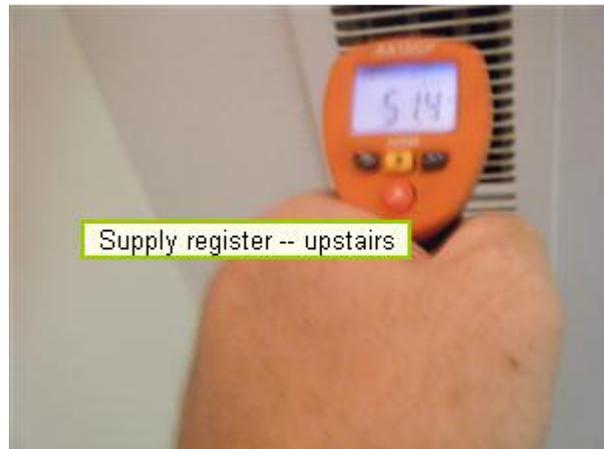
(1) When tested, it appears that the air conditioning for the upstairs is working well. For your reference, there should be at least a 14 degree difference between the air at the return air register and where the cooled air enters the home from the supply air register to indicate normal functioning. In this case, there was a 19 degree difference.

Please note the heat was not tested since the outside temperature was above 65 degrees to prevent possible damage to the compressor. It is likely that the heat is also working well.

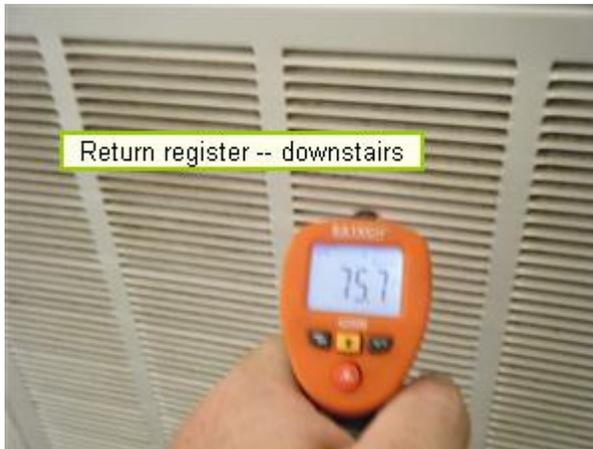
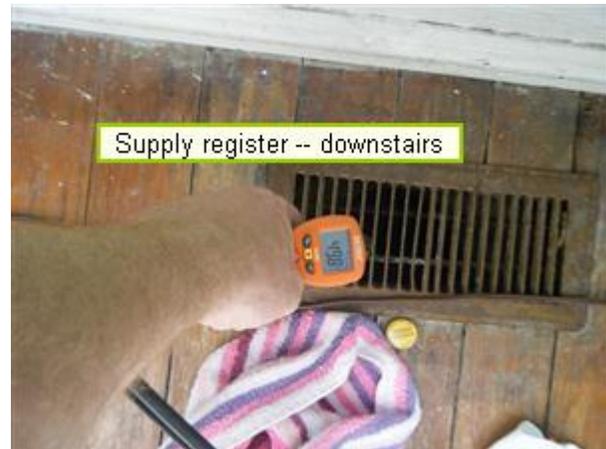
(2) When tested, it appears that the air conditioning for the downstairs is also working well. In this case, there was a 26 degree difference

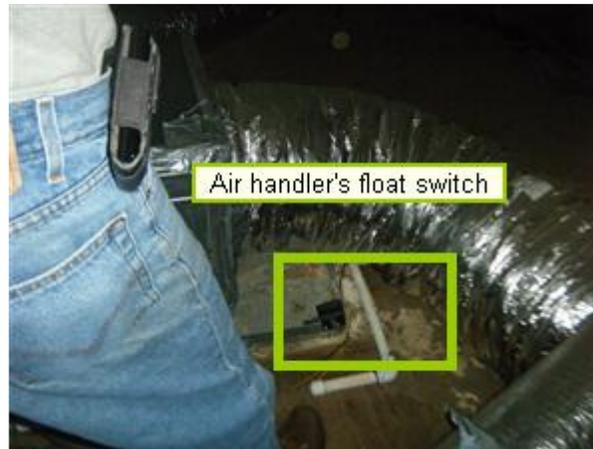
Please note the air handler has a 'float switch' which will turn off the outdoor compressor when the condensation pan (for the air handler) fills up to prevent the water from spilling over onto the floor below.

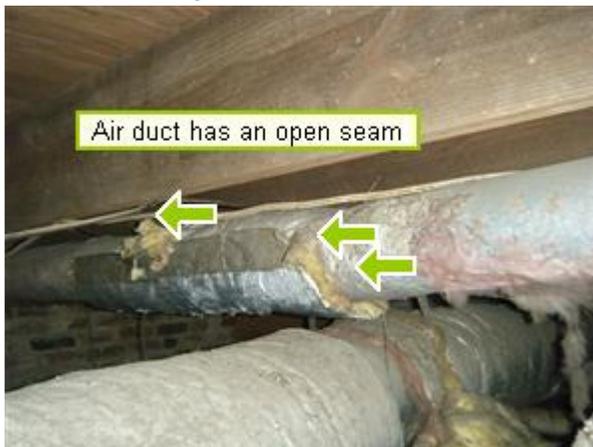
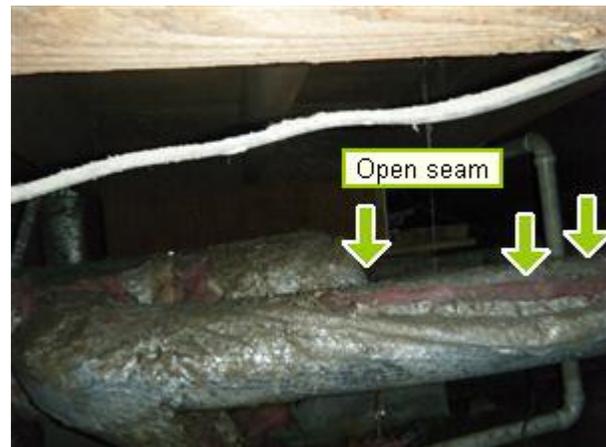
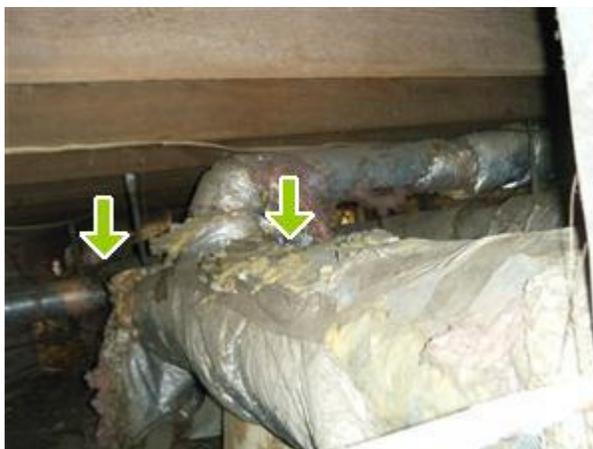
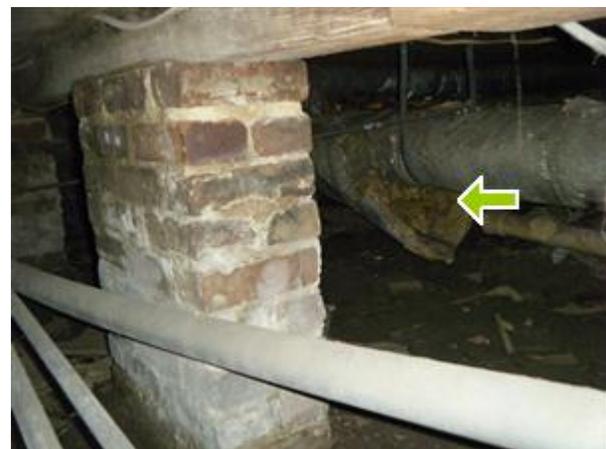
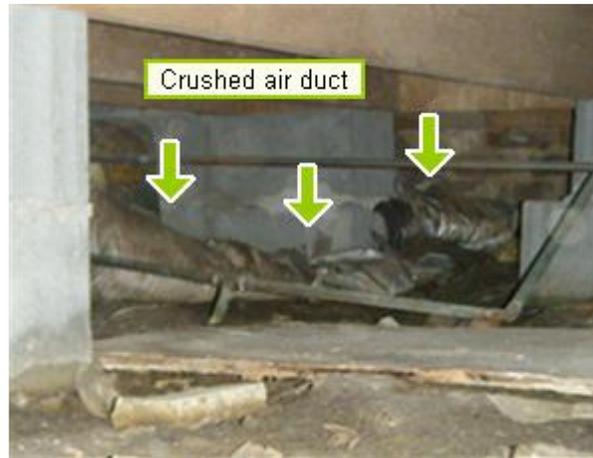
(1) Observed that some of air ducts in the crawlspace have open seams. Also, one of the air ducts is crushed. Recommend having an HVAC repairman evaluate the ducts and re-seal them anywhere a seam has opened -- this will save energy dollars and prevent condensation from forming in these areas.

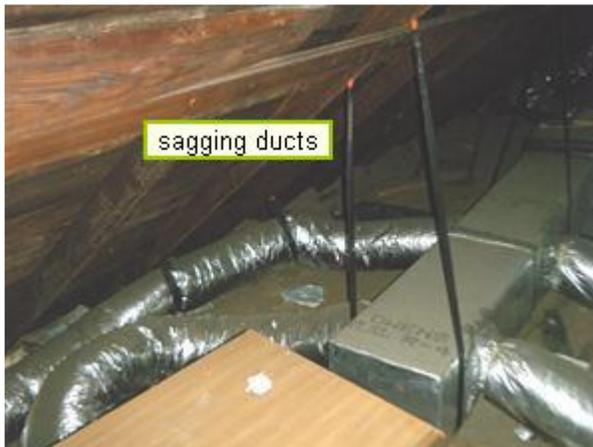
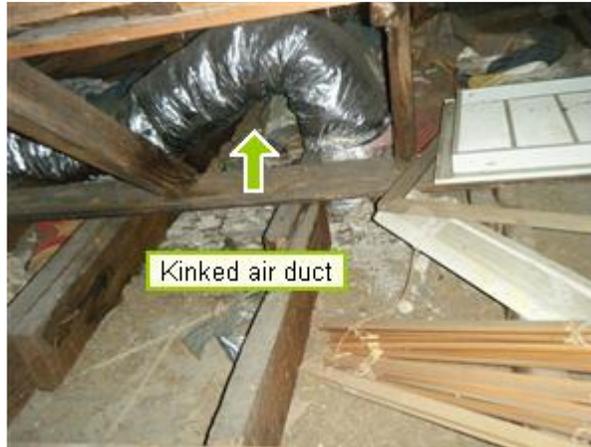
(2) As viewed from inside the attic, observed that one or more of the air ducts are sagging. For your reference, air ducts that aren't well supported can leak, condensation can form and drip onto the ground and/or air flow may be reduced which means that areas in the house may not be as comfortable as they could be. Recommend having a contractor or HVAC repairman add support for the ducts so they hang as straight as possible to facilitate good air flow.

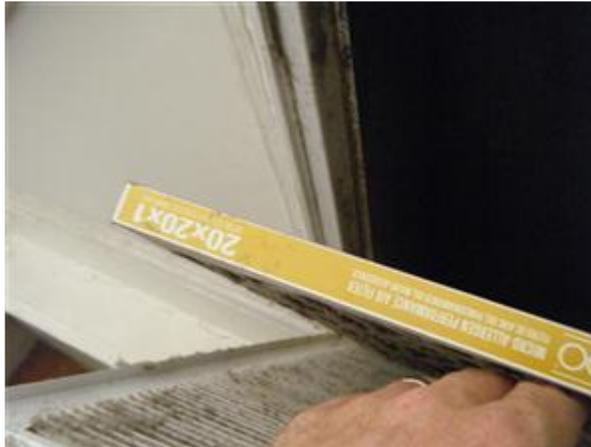
Observed that the size of the air filters are 20 x 20 and 20 x 25. Recommend using an inexpensive air filter and changing it frequently - ideally once a month. An easy way to remember to change the air filter is to change it when you pay the power bill each month. For your reference, the purpose of the air filter is to keep your furnace/air handler clean. A dirty, clogged filter blocks air flow and reduces the system's efficiency. If dirty air filters aren't changed regularly, the system can produce excess condensation which you may then see as a moisture stain on your ceiling. Please note the higher end filters make it more difficult for your furnace/air handler to draw and push air throughout your home, putting strain on your furnace/air handler and your energy bills.

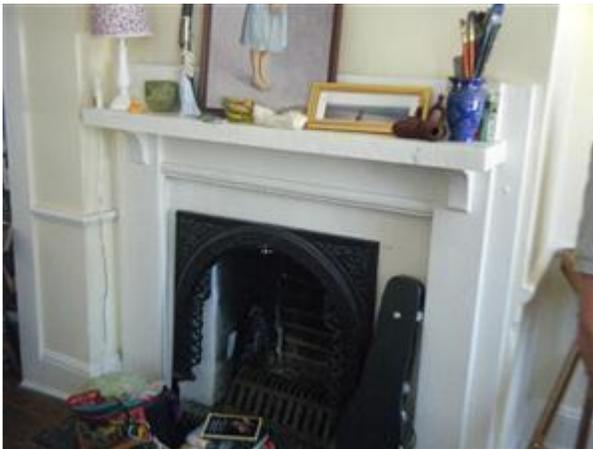
Observed that the fireplaces in the home have pillows in the chimneys to block the cold air. These old fireplaces are no longer functional -- DO NOT USE THEM FOR HEAT.

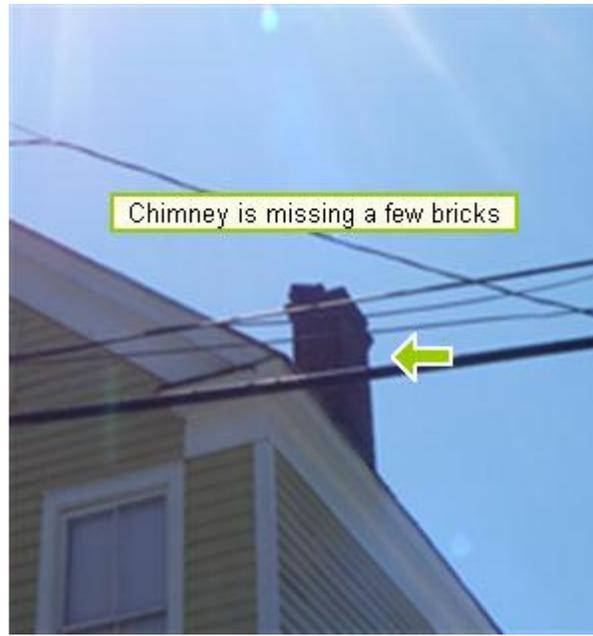
Observed that the exterior chimney is missing a few bricks. Recommend having a contractor make the needed repairs or remove the chimney altogether so it doesn't fall onto the neighbor's car.
